## CHAPTER V

# STRUCTURAL DAMAGE FROM AIR BLAST

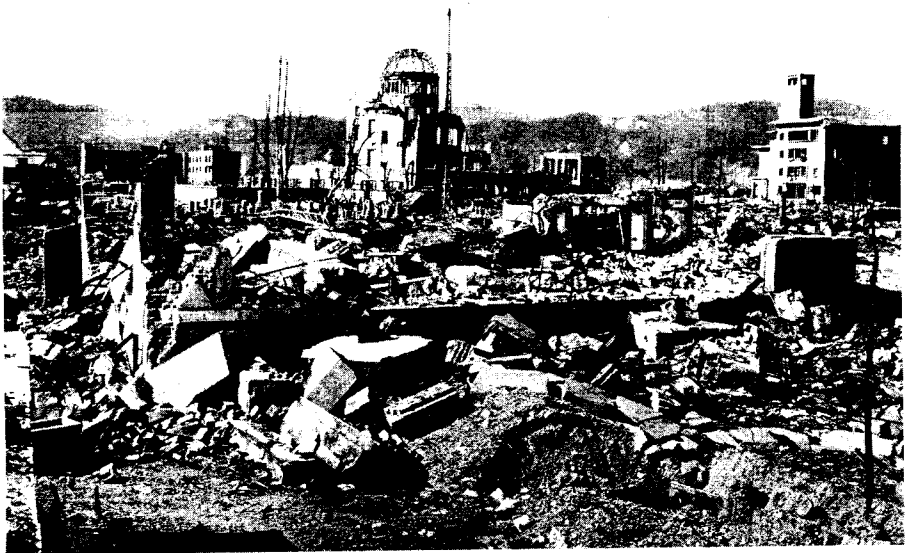
enormous numbers of flying missiles consisting of bricks (and other masonry), glass, pieces of wood and metal, etc. These caused considerable amounts of secondary damage to structures and utilities, and numerous casualties even in the lightly damaged areas. In addition, the large quantities of debris resulted in the blockage of streets, thus making rescue and fire-fighting operations extremely difficult (Fig. 5.06).

Figure 5.06. Debris after the nuclear explosion at Hiroshima.

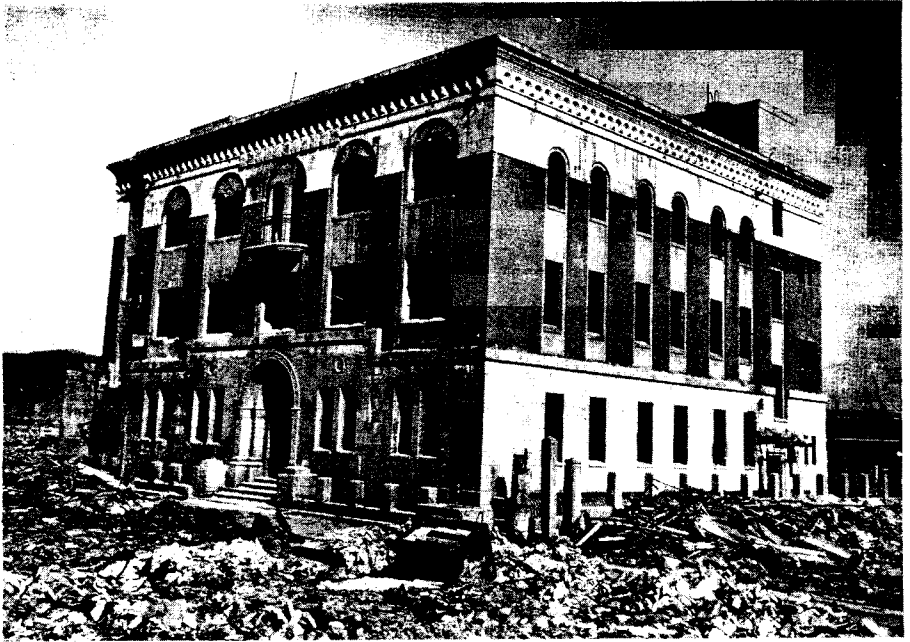
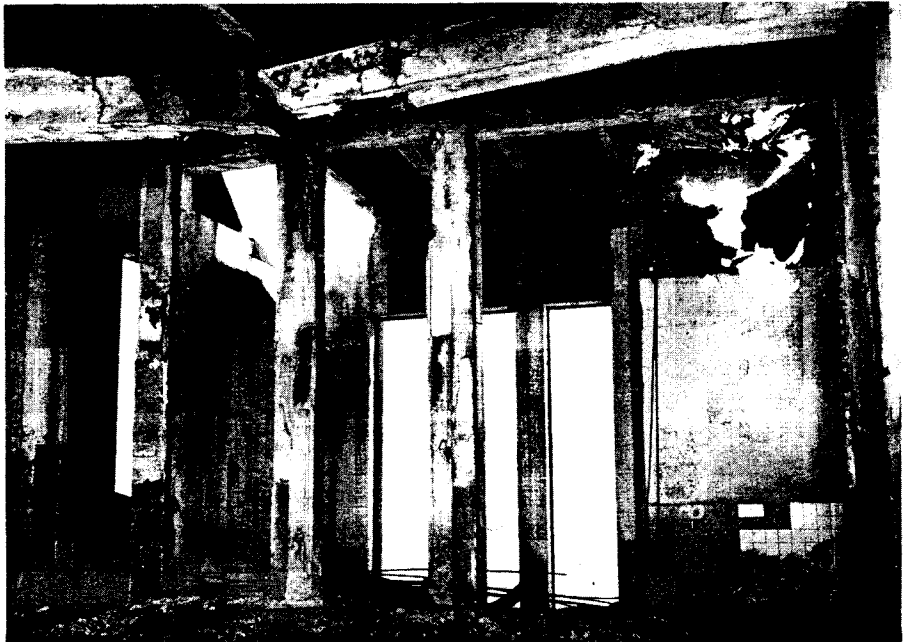
the interior and contents due to the entry of blast through doors and window openings and to subsequent fires. An exceptionally strong structure of earthquake-resistant (aseismic) design, located some 640 feet from ground zero in Hiroshima, is seen in Fig. 5.20a. Although the exterior walls were hardly damaged, the roof was depressed and the interior was destroyed. More typical of reinforced-concrete frame construction in the United States was the building shown in Fig. 5.20b at about the same distance from ground zero. This suffered more severely than the one of aseismic design.

Figure 5.20a. Upper photo: Reinforced-concrete, aseismic structure; window fire shutters were blown in by blast and the interior gutted by fire (0.12 mile from ground zero at Hiroshima). Lower photo: Burned out interior of similar structure.

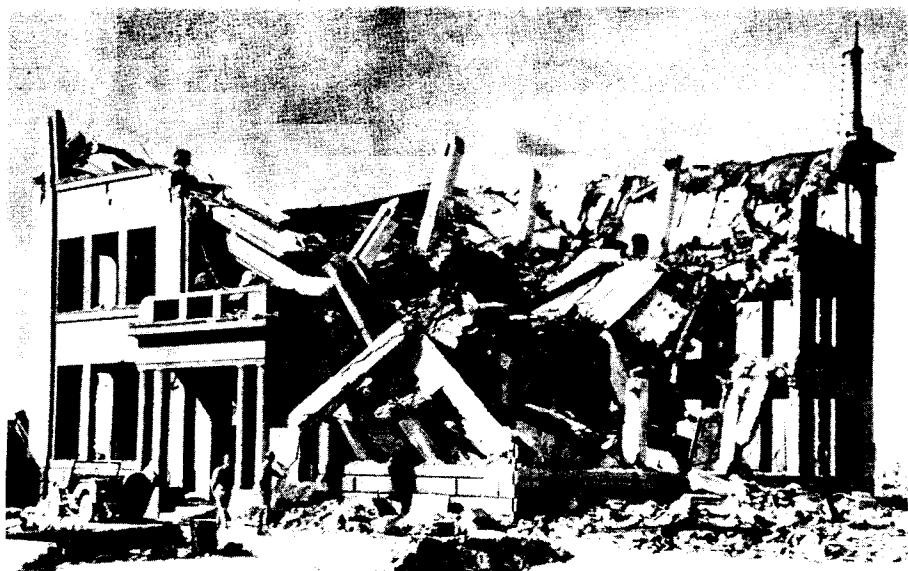
Figure 5.20b. Three-story, reinforced-concrete frame building; walls were 13-inch thick brick panel with large window openings (0.13 mile from ground zero at Hiroshima).

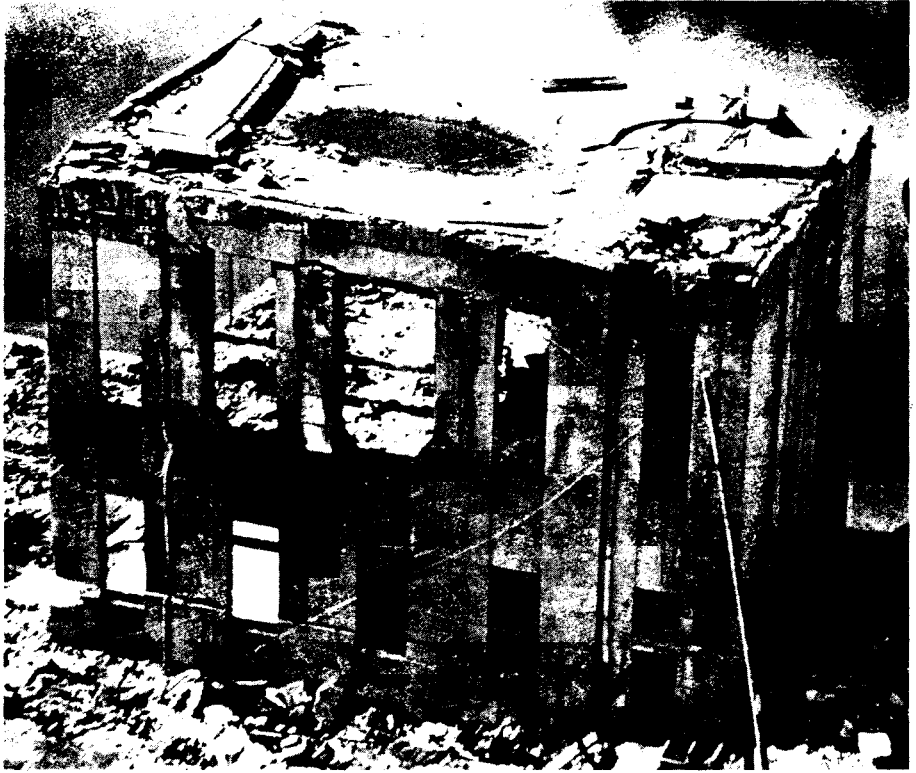
**5.22** Close to ground zero the vertical component of the blast was more significant and so greater damage to the roof resulted from the downward force (Fig. 5.22a) than appeared farther away. Depending upon its strength, the roof

was pushed down and left sagging or it failed completely. The remainder of the structure was less damaged than similar buildings farther from the explosion because of the smaller horizontal (lateral) forces. At greater distances, from ground zero, especially in the region of Mach reflection, the consequences of horizontal loading were apparent (Fig. 5.22b).

Figure 5.22a. Depressed roof of reinforced-concrete building (0.10 mile from ground zero at Hiroshima).

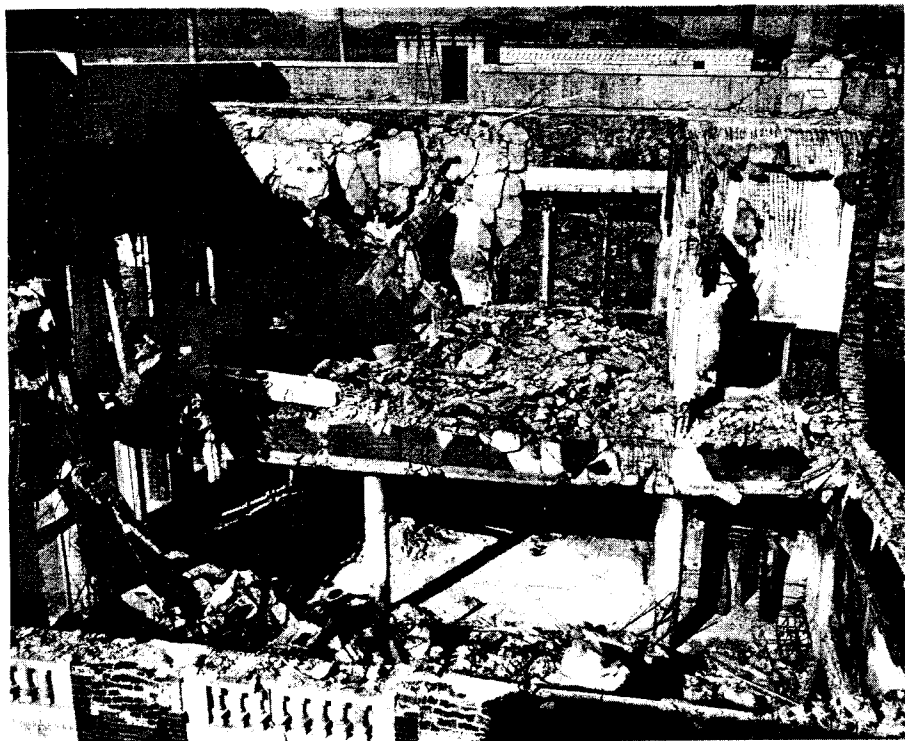
5.23 In addition to the failure of roof slabs and the lateral displacement of walls, numerous other blast effects were observed. These included bending and fracture of beams, failure of columns, crushing of exterior wall panels, and failure of floor slabs (Fig. 5.23). Heavy damage to false ceilings, plaster, and partitions occurred as far out as 9,000 feet (1.7 miles) from ground zero, and glass windows were generally bro-

Figure 5.23. Reinforced-concrete building showing collapsed roof and floor slabs (0.10 mile from ground zero at Nagasaki).

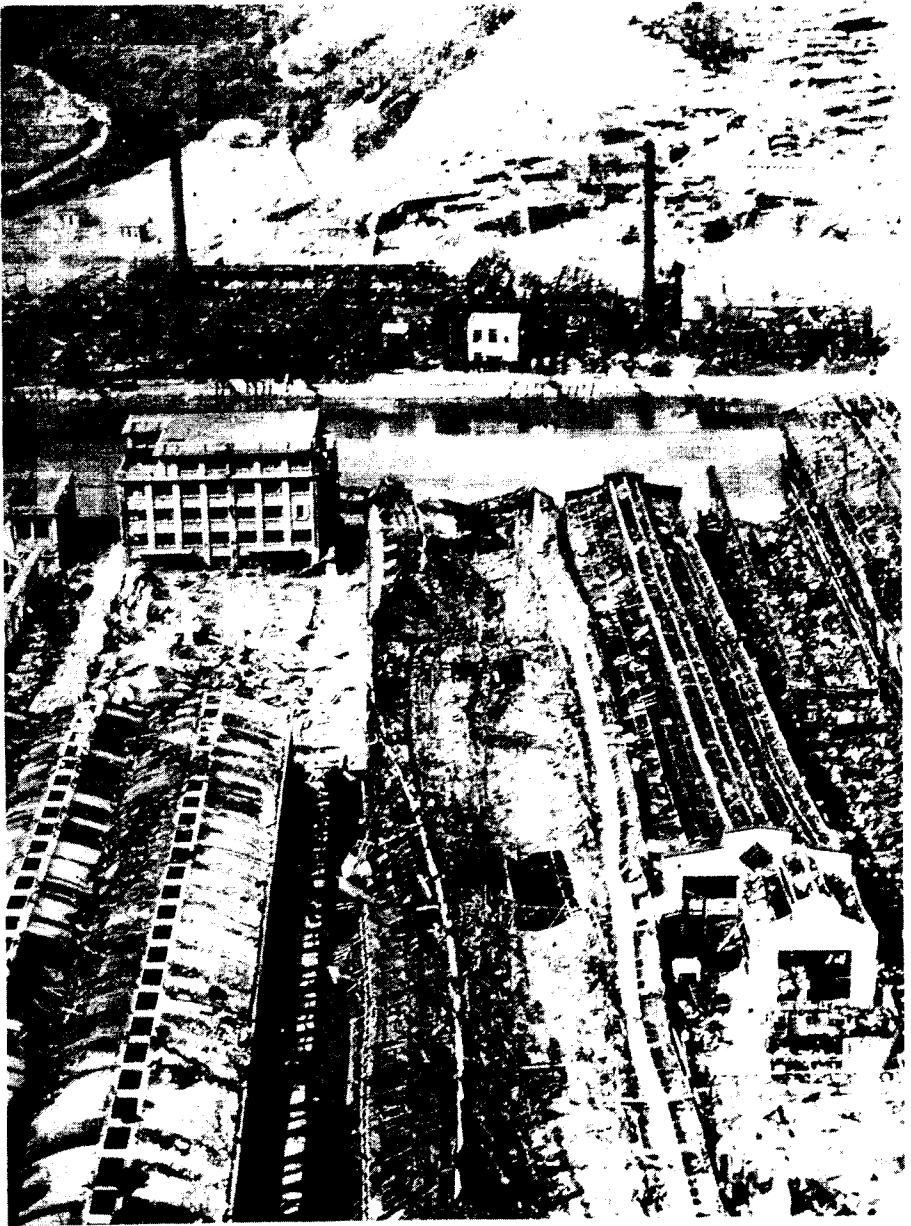
ground zero (Fig. 5.25). The only part of the building that was not regarded as being of heavy construction was the roof, which was of 4-inch thick reinforced concrete supported by unusually light steel trusses. The downward failure of the roof, which was dished 3 feet, was the only important structural damage suffered.

Figure 5.25. At left and back of center is a multistory, steel-frame building (0.85 mile from ground zero at Nagasaki).

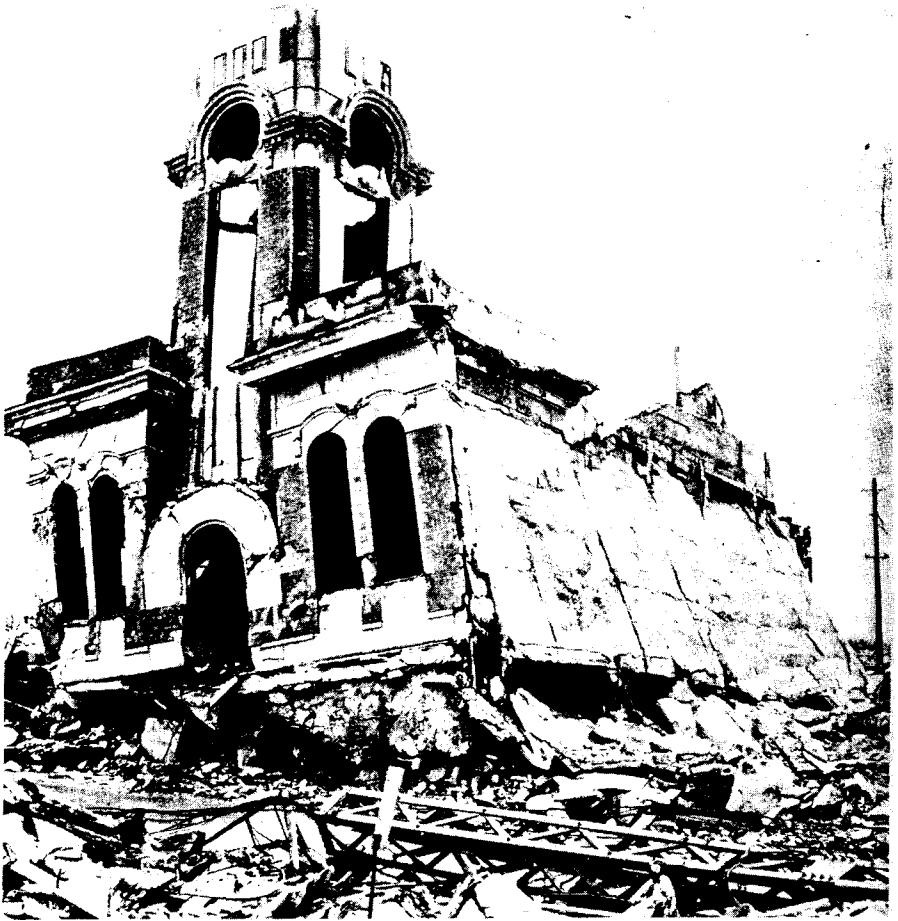
shown in Fig. 5.26. The heavy walls of the structure transmitted their loads to the steel frame, the columns of which collapsed. Weakening of unprotected steel by fire could have contributed significantly to the damage to steel-frame structures (§ 5.31).

Figure 5.26. Two-story, steel-frame building with 7-inch reinforced-concrete wall panels (0.40 mile from ground zero at Hiroshima). The first story columns buckled away from ground zero dropping the second story to the ground.

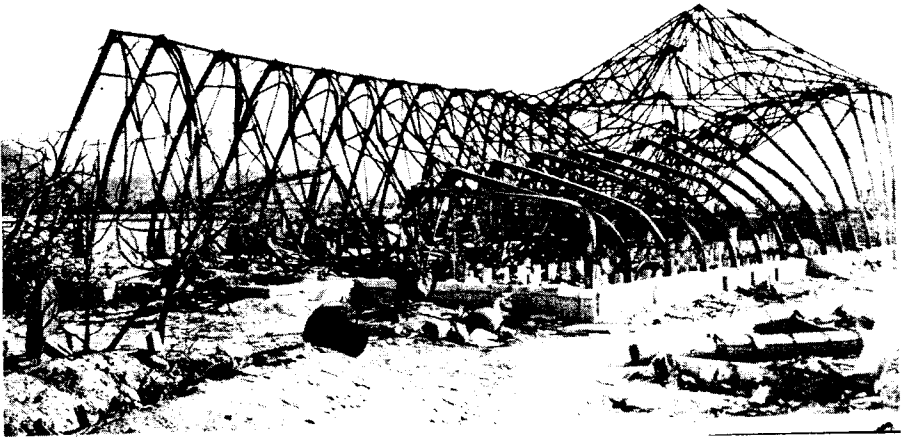
5.29 Severe damage of these structures occurred up to a distance of about 6,000 feet (1.14 miles) from ground zero. Moderately close to ground zero, the buildings were pushed over bodily, and at greater distances they were generally left leaning away from the source of the blast (Fig. 5.29). The columns being long and slender offered little resistance to the lateral loading. Sometimes columns failed due to a lateral

force causing flexure, combined with a simultaneous small increase in the downward load coming from the impact of the blast on the roof. This caused buckling and, in some instances, complete collapse. Roof trusses were buckled by compression resulting from lateral blast loading on the side of the building facing the explosion.

Figure 5.29. Single-story, light steel-frame building (0.80 mile from ground zero at Hiroshima); partially damaged by blast and further collapsed by subsequent fire.

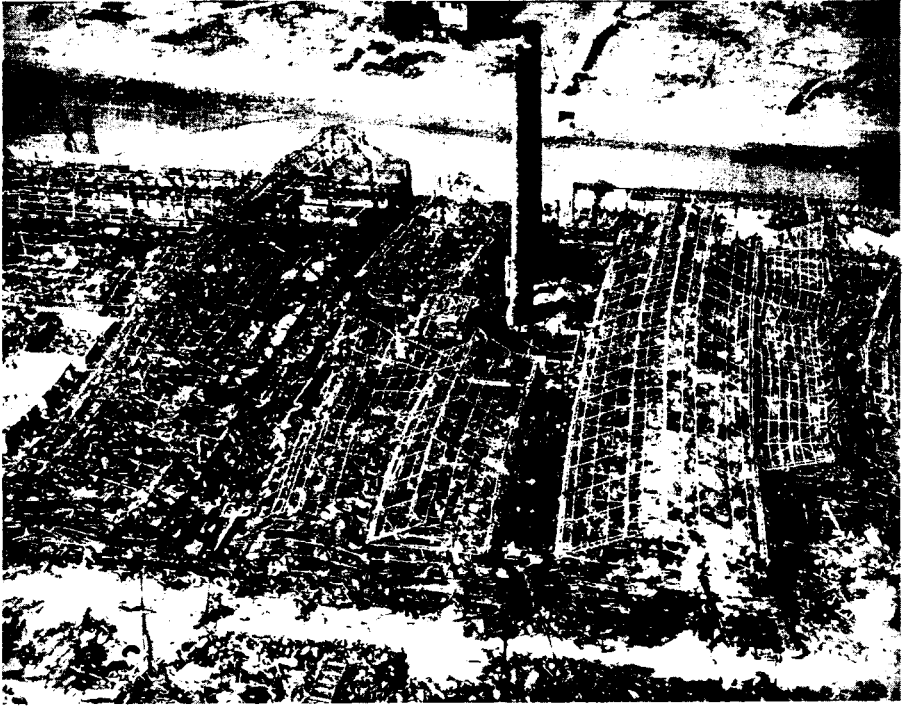
**5.34** Smokestacks, especially those of reinforced concrete, proved to have considerable blast resistance (Fig. 5.34a). Because of their shape, they are subjected essentially to drag loading only and, if sufficiently strong, their long period of vibration makes them less sensitive to blast than many other structures. An example of extreme damage to a reinforced-concrete stack is shown in Fig. 5.34b. Steel smokestacks performed reasonably well, but being lighter in weight and subject to crushing were not comparable to reinforced concrete. On the whole, well-constructed masonry stacks withstood the blast

Figure 5.34a. Destroyed industrial area showing smokestacks still standing (0.51 mile from ground zero at Nagasaki).

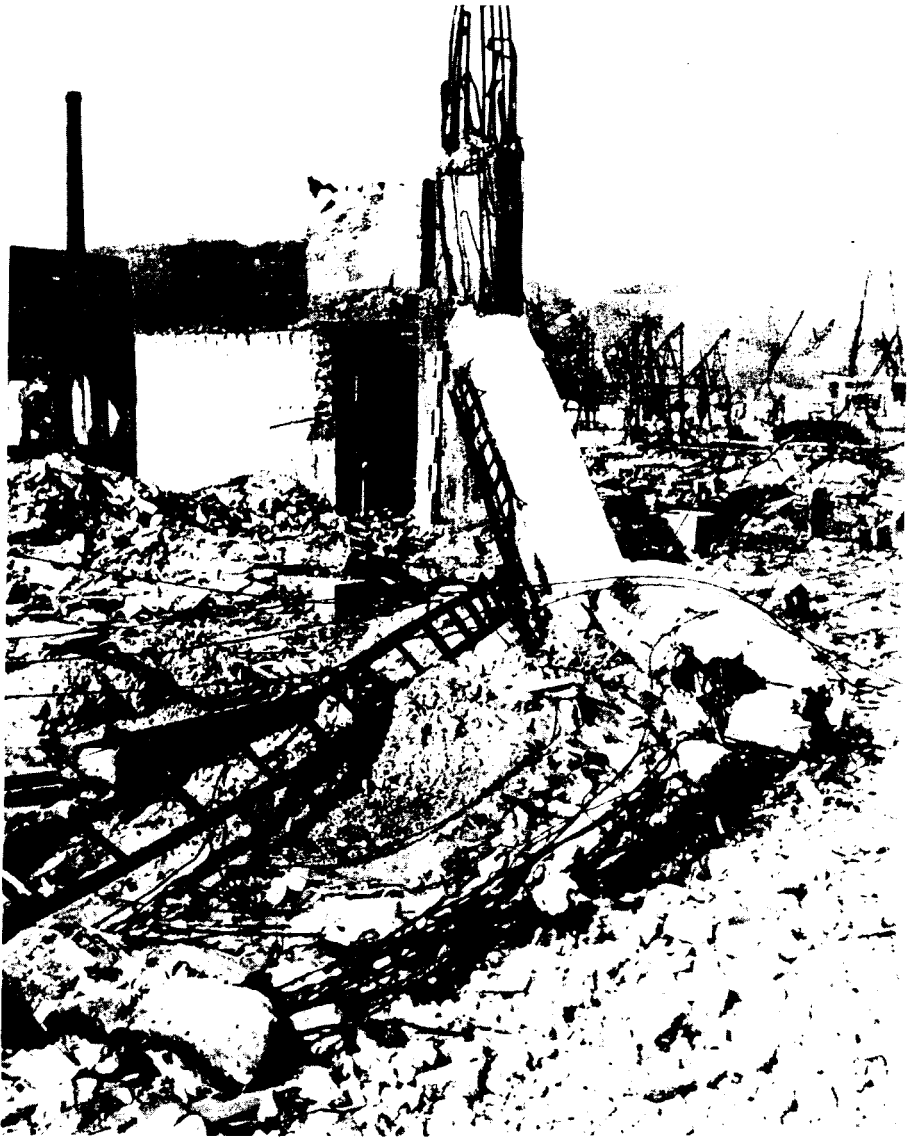
Figure 5.34b. A circular, 60 feet high, reinforced-concrete stack (0.34 mile from ground zero at Hiroshima). The failure caused by the blast wave occurred 15 feet above the base.

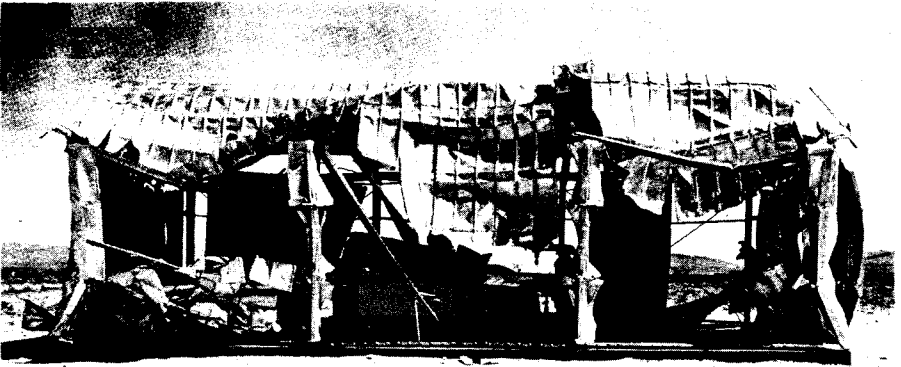
**5.37** The first industrial type building had a conventional rigid steel frame, which is familiar to structural engineers, with aluminum-sheet panels for roofing and siding (Fig. 5.37a). At a blast overpressure of 3.1 pounds per square inch this building was severely damaged. The welded and bolted steel frame

Figure 5.37b. Rigid steel-frame building after a nuclear explosion (3.1 psi peak overpressure).

**5.39** As presently designed, structures of this type may be regarded as being repairable, provided they are not exposed to blast pressures exceeding 1 pound per square inch. Increased blast resistance would probably result from improvement in the design of girts and purlins (horizontal members supporting rafters), in particular. Better fastening between sill and wall footing and increased resistance to transverse loading would also be beneficial.

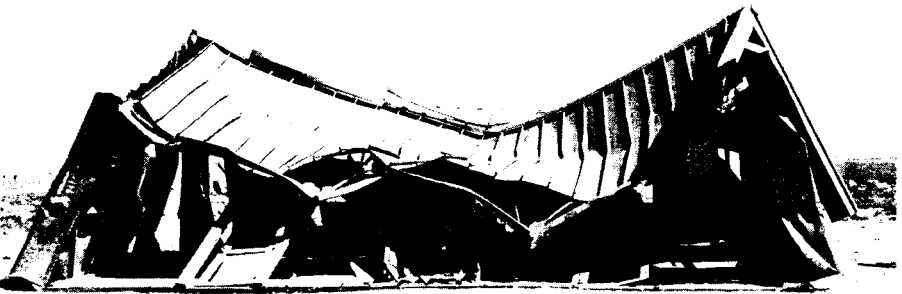
0.2 pound per square inch) was completely demolished (Fig. 5.40b). One or two segments of wall were blown as far as 50 feet away, but, in general, the bent and twisted segments of the building remained approximately in their original locations. Most of the wall sections were still attached to their foundation bolts on the side and rear walls of the

Figure 5.40b. Self-framing steel panel building after a nuclear explosion (3.1 psi peak overpressure).

5.42 It appears that the steel panel type of structure is repairable if exposed to overpressures of not more than about  $\frac{3}{4}$  to 1 pound per square inch. The buildings are simple to construct but they do not hold together well under

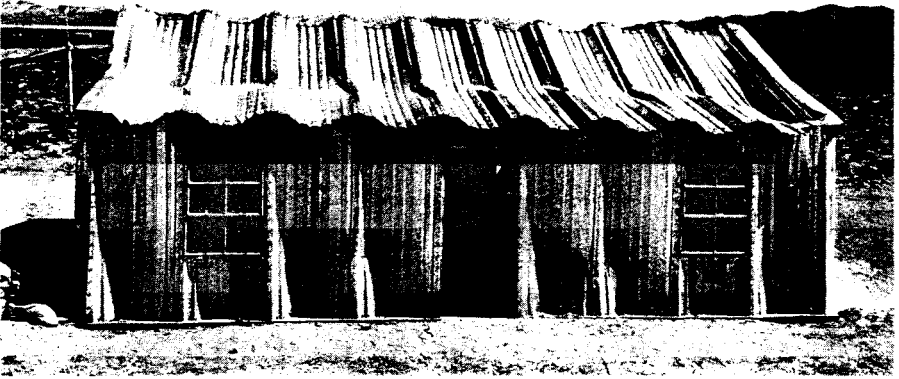
Figure 5.44. Self-framing corrugated steel panel building after a nuclear explosion (3.1 psi peak overpressure).

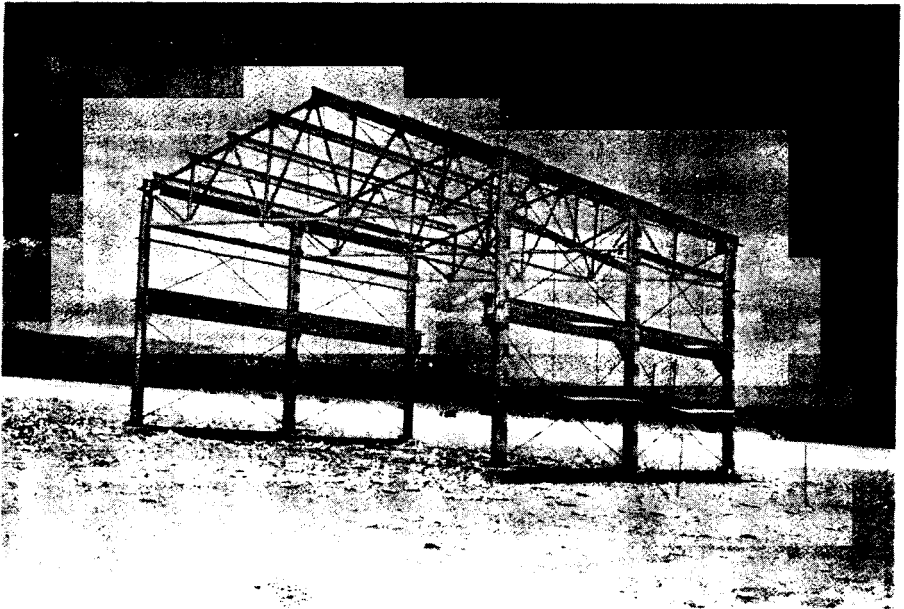
Figure 5.49. Structure in Figure 5.48a after exposure to 6.5 psi peak overpressure and 1.1 psi dynamic pressure; positive phase duration 0.9 second.

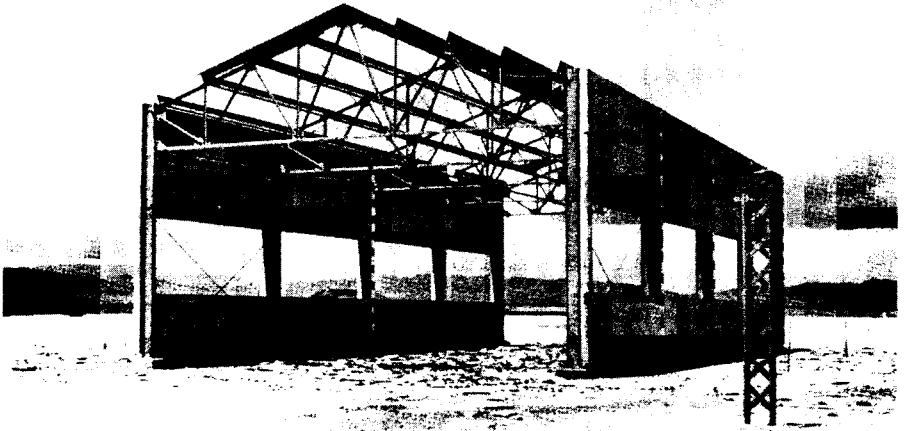
Figure 5.50. Structure in Figure 5.48b after exposure to 3.5 psi peak overpressure and 0.3 psi dynamic pressure; positive phase duration 1 second.

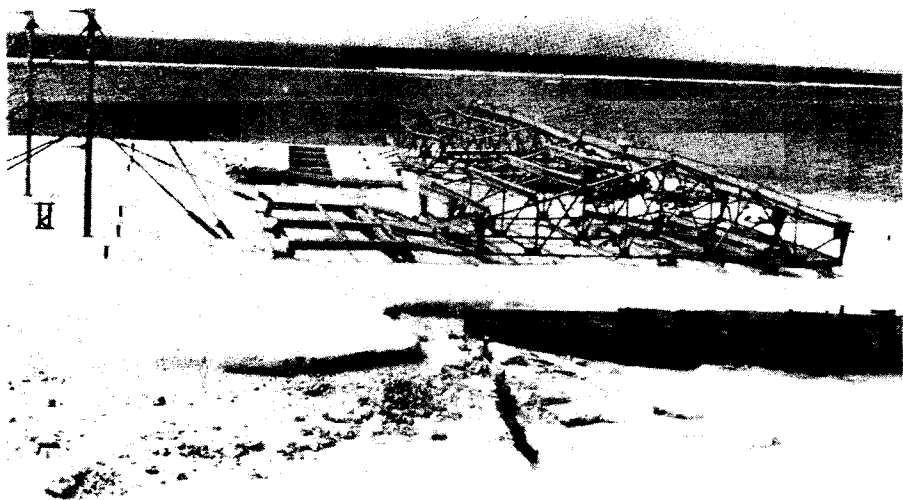
Figure 5.51a. Structure similar to Figure 5.48a after exposure to 6.1 psi peak overpressure and 0.6 psi dynamic pressure; positive phase duration several seconds.

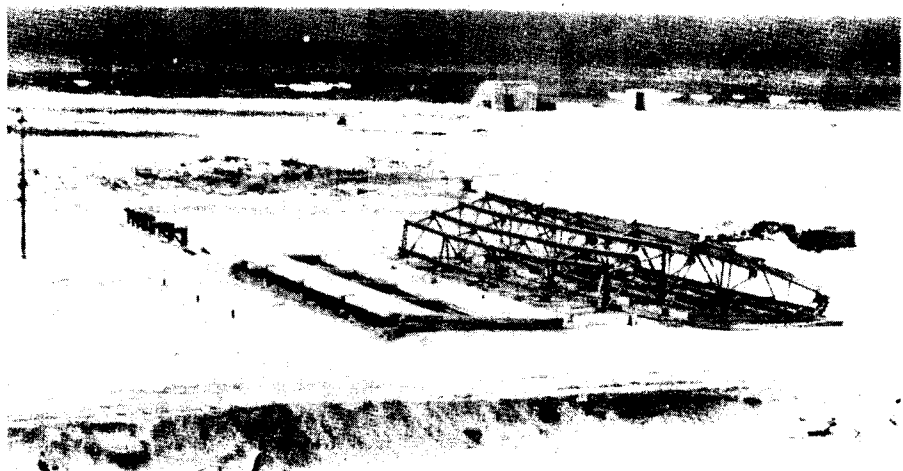
Figure 5.51b. Structure similar to Figure 5.48b after exposure to 5 psi peak overpressure and 0.5 psi dynamic pressure; positive phase duration several seconds.

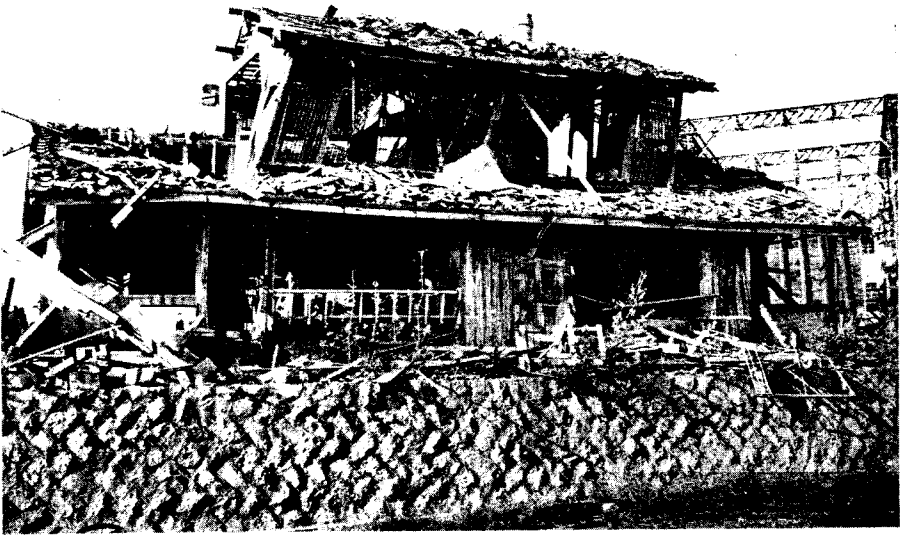
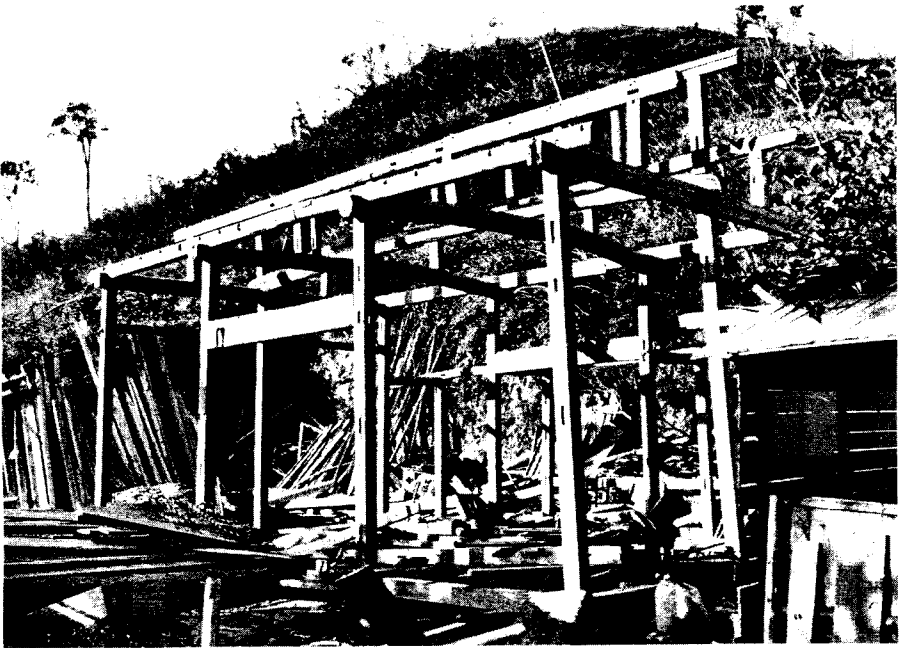
appeared that, although the quality of the workmanship in framing was usually high, little attention was paid to good engineering principles. On the whole, therefore, the construction was not well adapted to resist wracking action (distortion). For example, mortise and tenon joints were weak points in the

Figure 5.52. Upper photo; Wood-frame building; 1.0 mile from ground zero at Hiroshima.  
Lower photo: Frame of residence under construction, showing small tenons.

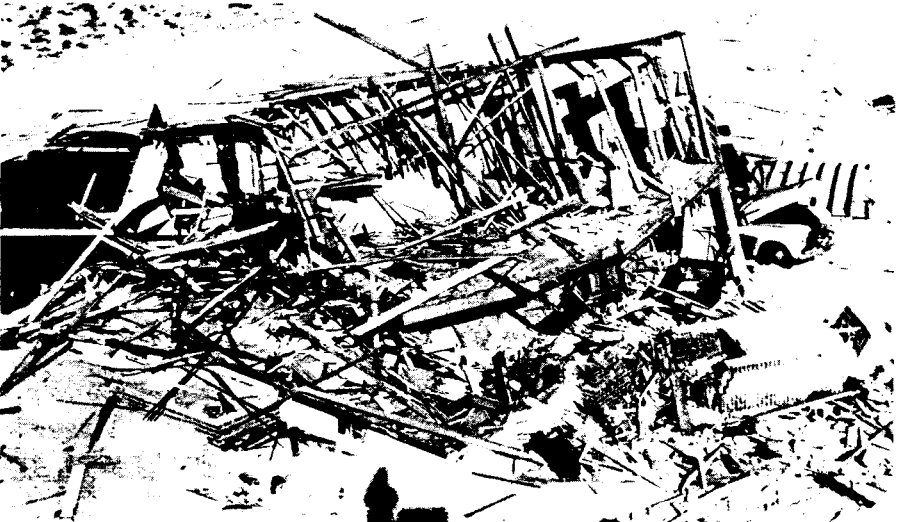
**5.57** Some indication of the blast damage suffered by this dwelling can be obtained from Fig. 5.57. It is apparent that the house was ruined beyond repair. The first story was completely demolished and the second story, which was very badly damaged, dropped down on the first floor debris. The roof was blown off in several sections which landed at both front and back of the house. The gable end walls were blown apart and outward, and the brick chimney was broken into several pieces.

Figure 5.57. Wood-frame house after a nuclear explosion (5 psi peak overpressure).

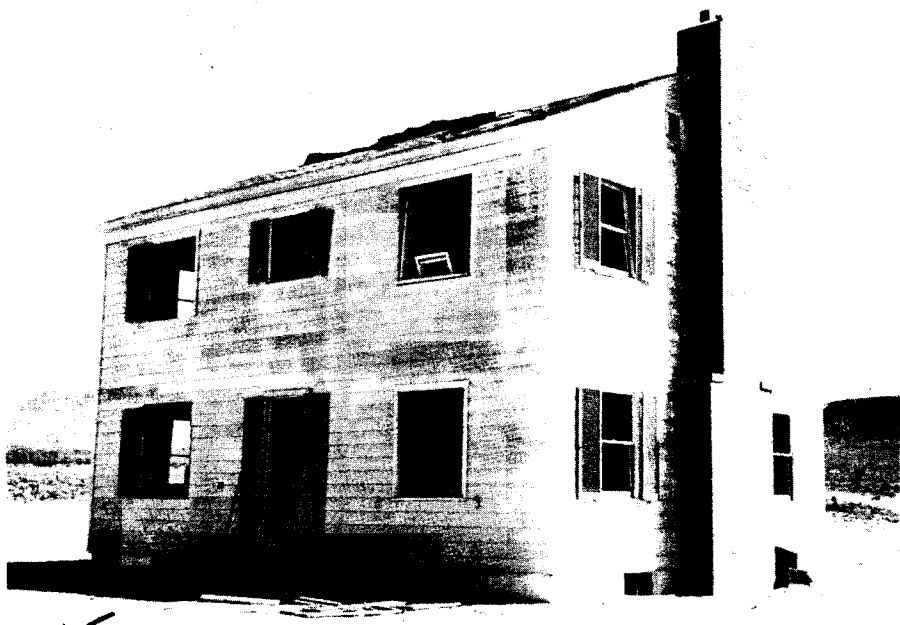
Figure 5.59. Wood-frame house after a nuclear explosion (1.7 psi peak overpressure).

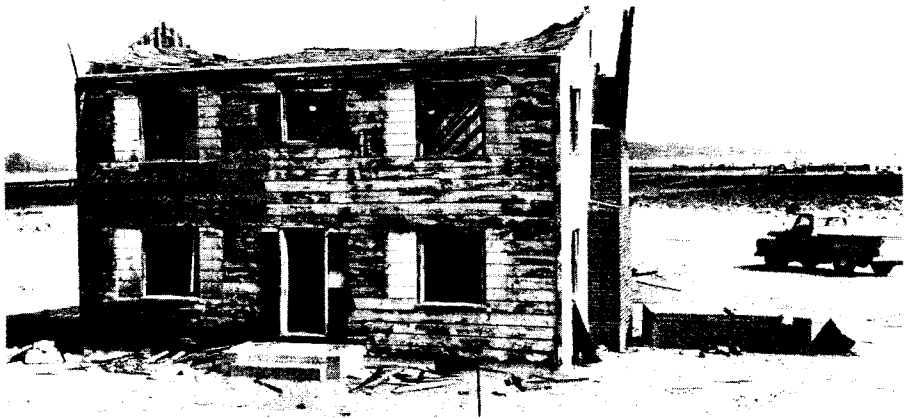
Figure 5.64. Strengthened wood-frame house after a nuclear explosion (4 psi peak overpressure).

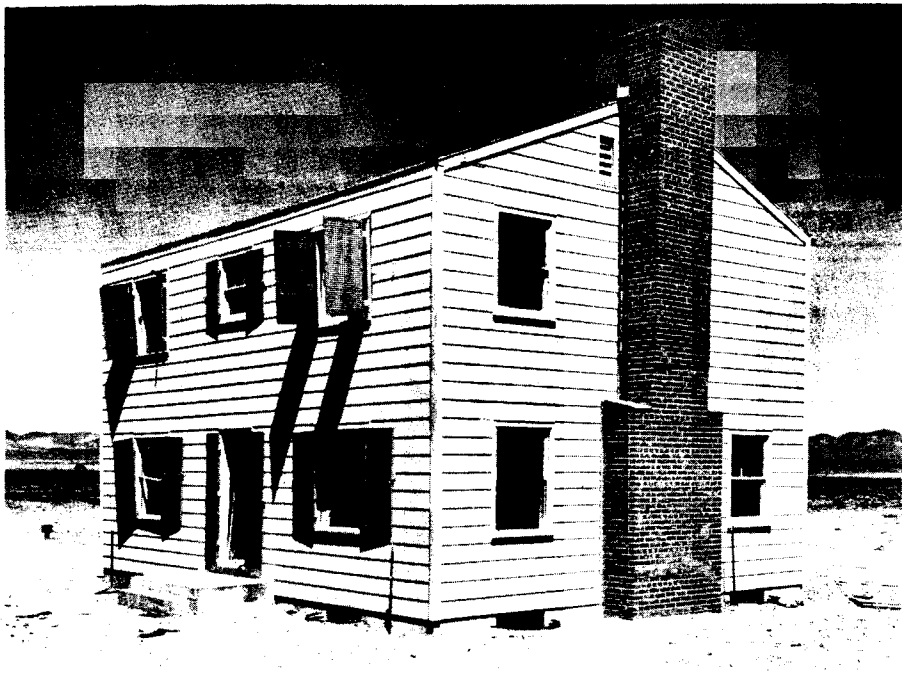
Figure 5.65. Strengthened wood-frame house after a nuclear explosion (2.6 psi peak overpressure).

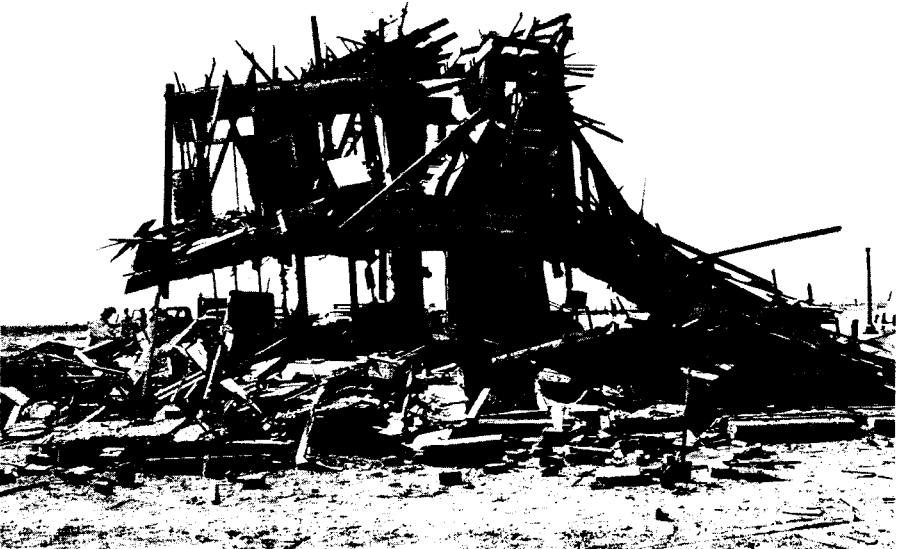
Figure 5.67. Unreinforced brick house after a nuclear explosion (5 psi peak overpressure).

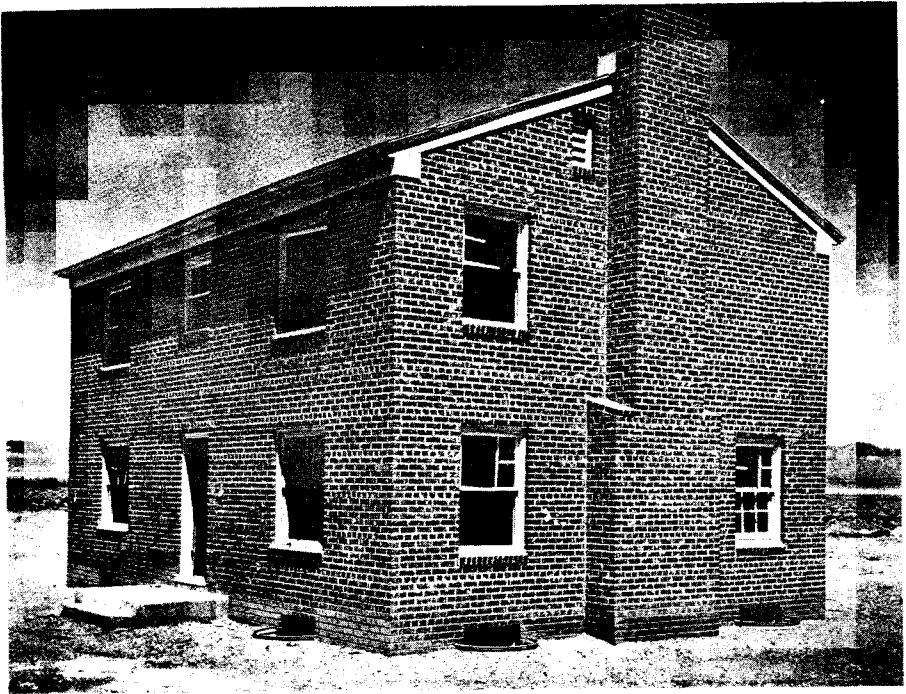
Figure 5.68. Unreinforced brick house after a nuclear explosion (1.7 psi peak overpressure).

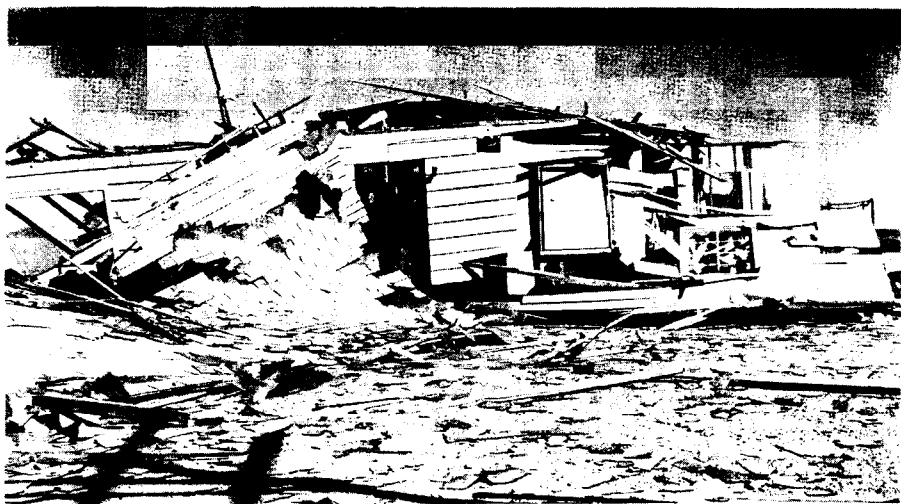
Figure 5.70. Rambler-type house after a nuclear explosion (5 psi peak overpressure).

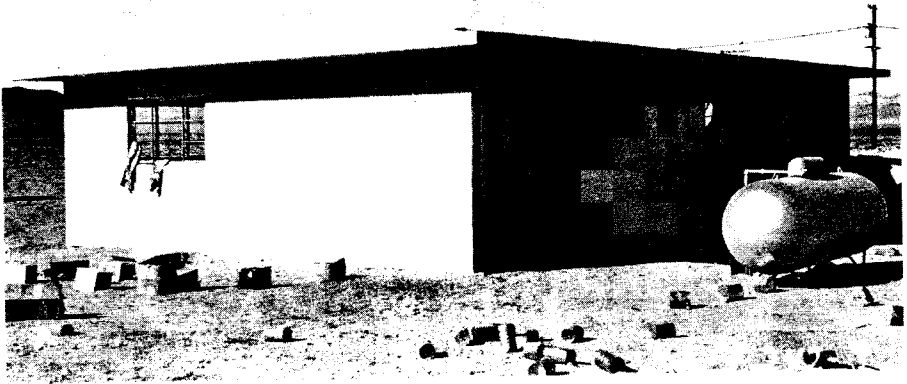
Figure 5.73. Reinforced precast concrete house after a nuclear explosion (5 psi peak overpressure). The LP-gas tank, sheltered by the house, is essentially undamaged.

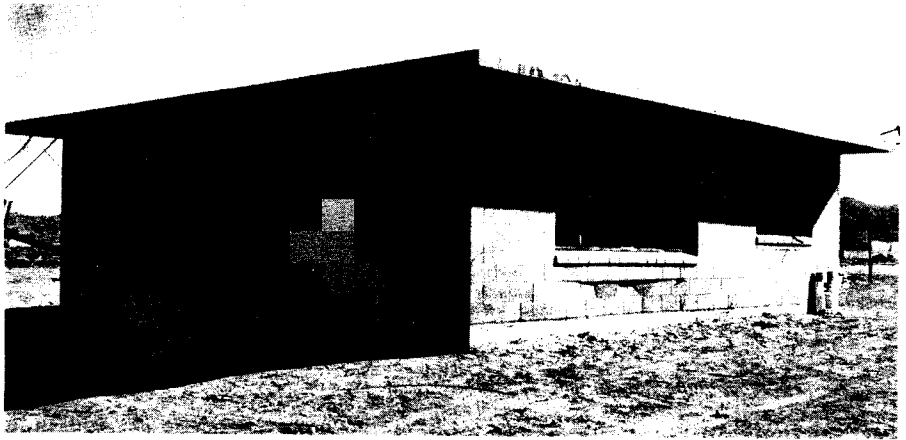
Figure 5.77. Reinforced masonry-block house after a nuclear explosion (5 psi peak overpressure).

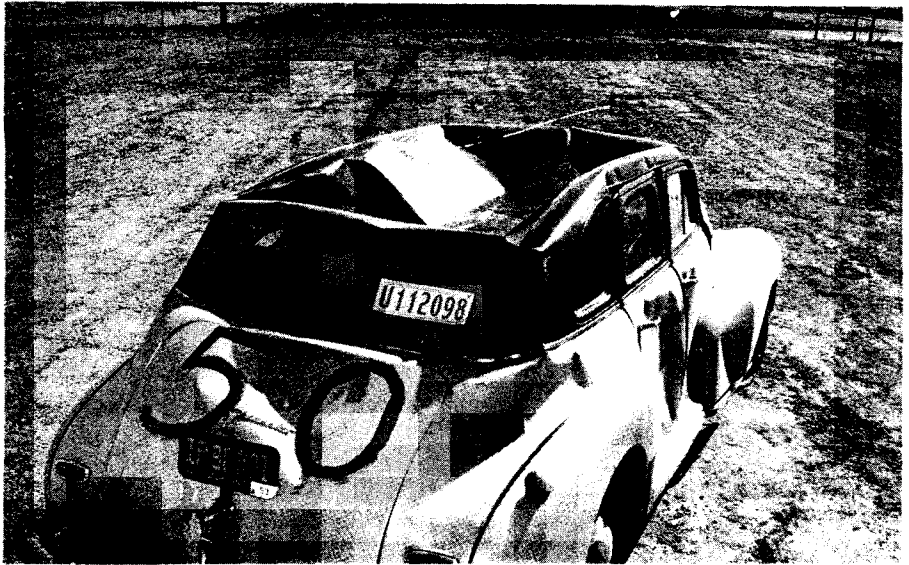
Figure 5.87a. Damage to automobile originally located behind wood-frame house (5 psi peak overpressure); the front of this car can be seen in Figure 5.57. Although badly damaged, the car could still be driven after the explosion.

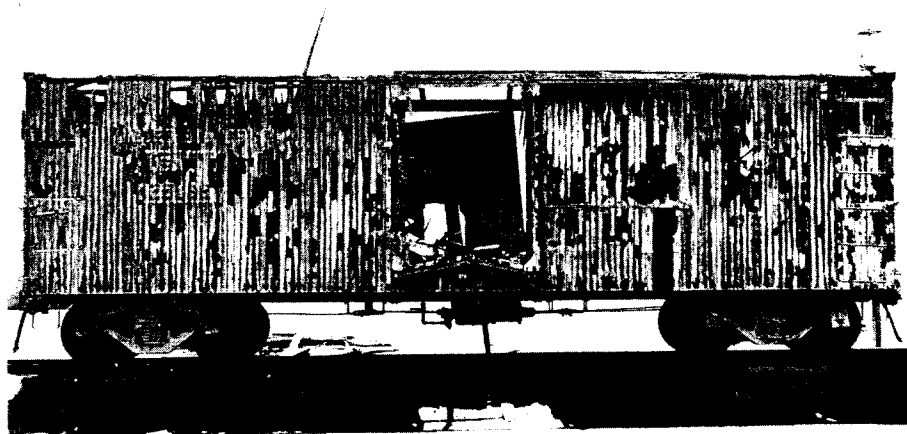
Figure 5.92a. Loaded wooden boxcar after a nuclear explosion (4 psi peak overpressure).

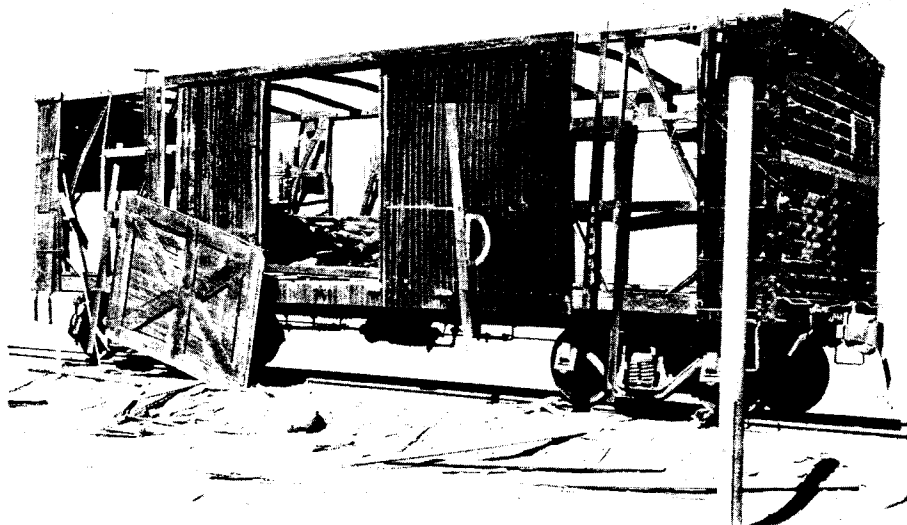
Figure 5.92b. Loaded wooden boxcar after a nuclear explosion (6 psi peak overpressure).

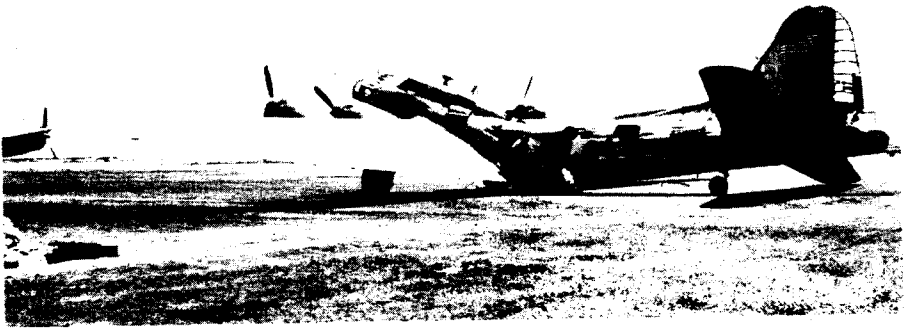
Figure 5.95a. Aircraft after side exposed to a nuclear explosion (3.6 psi peak overpressure).

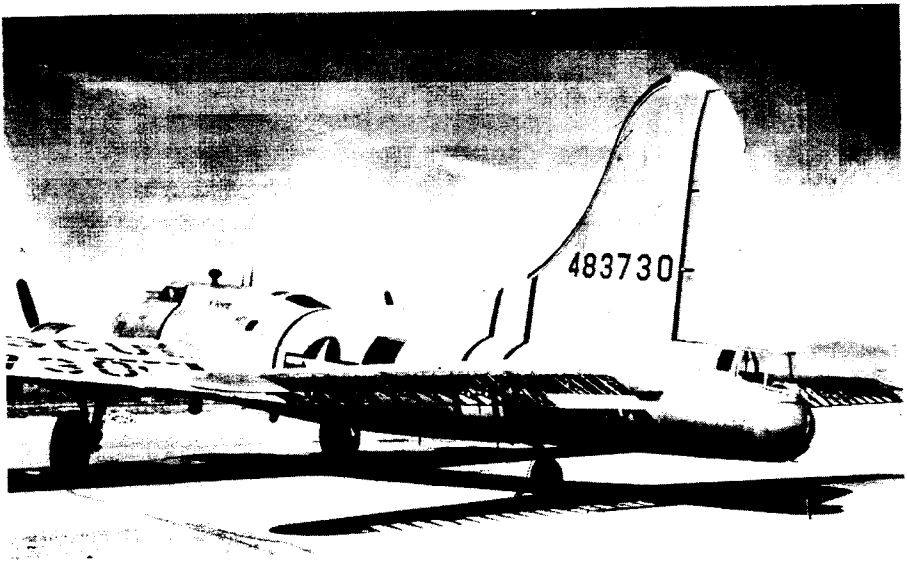
Figure 5.95b. Aircraft after tail exposed to a nuclear explosion (2.4 psi peak overpressure).

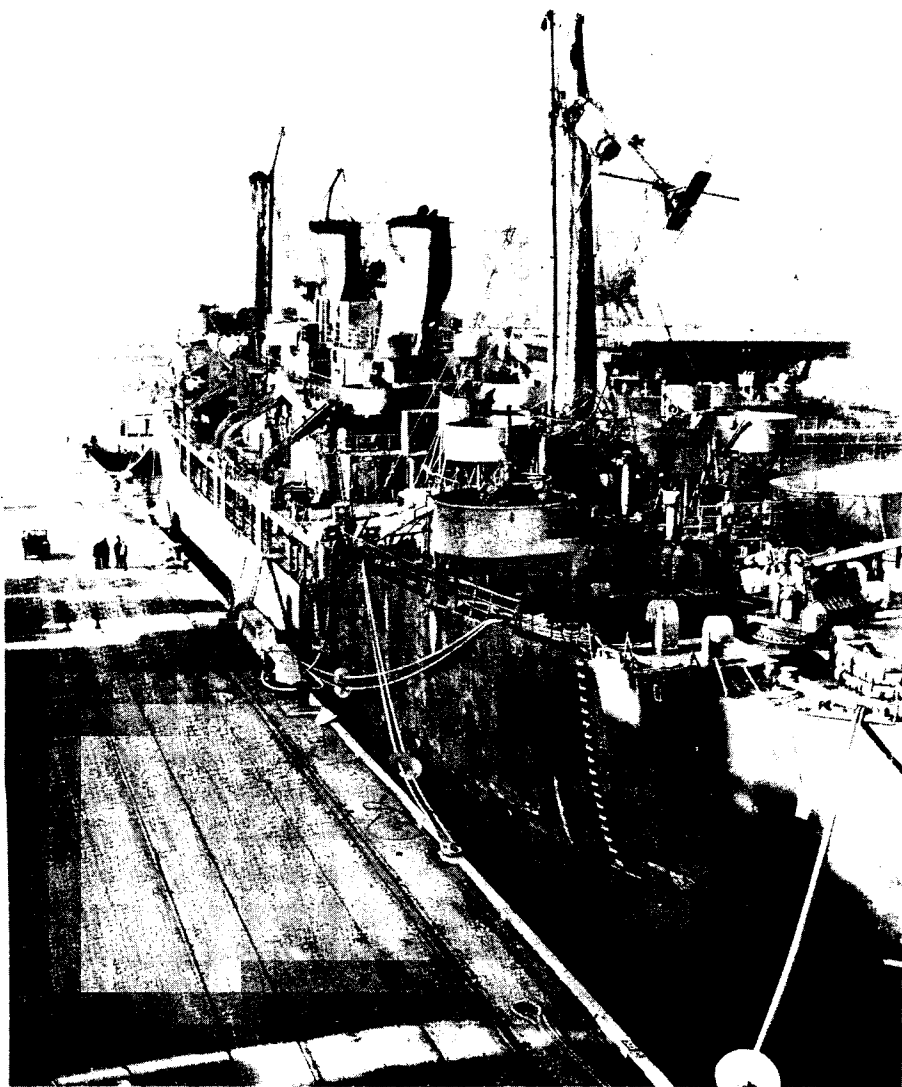
Figure 5.96. The U.S.S. Crittenden after ABLE test; damage resulting was generally serious (0.47 mile from surface zero).

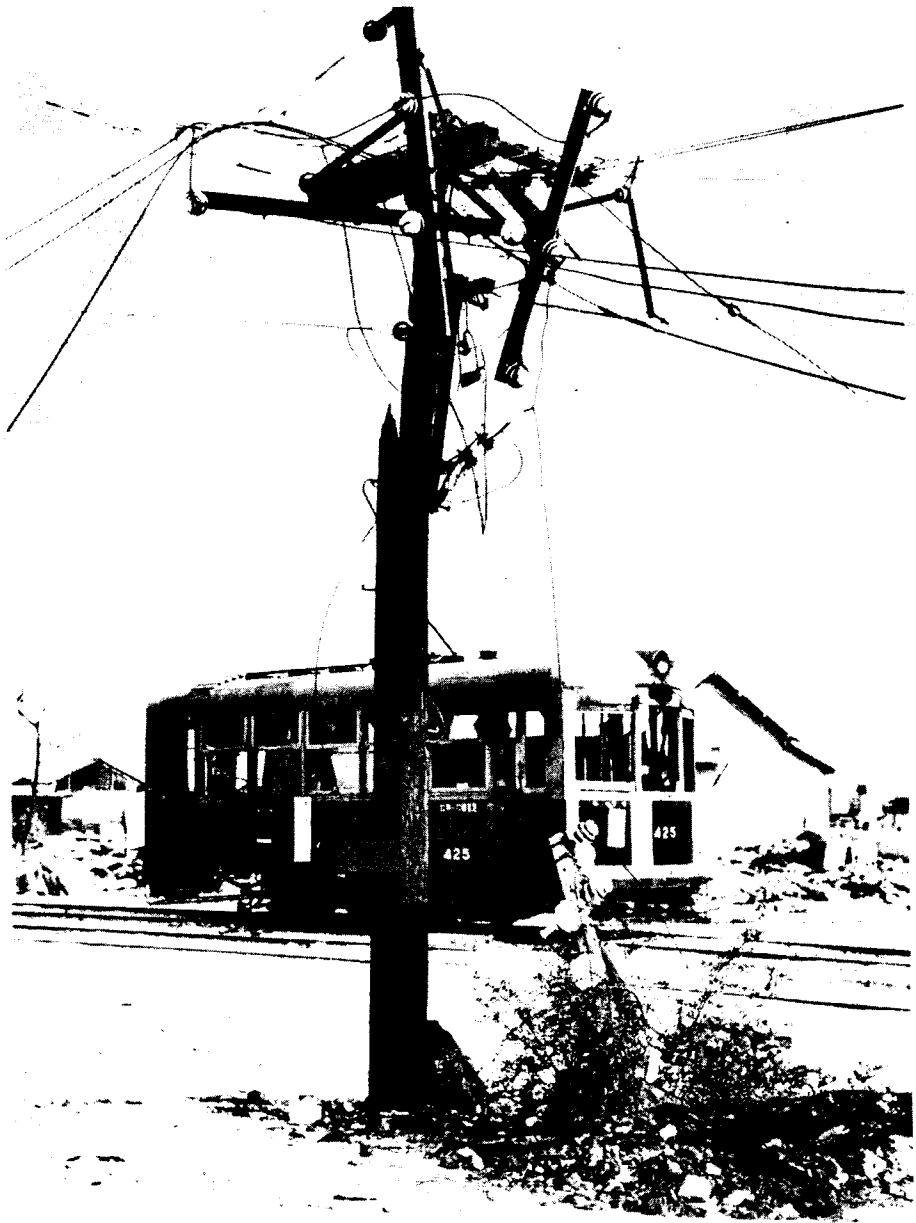
Figure 5.98. Damage to utility pole (0.80 mile from ground zero at Hiroshima).
