## CHAPTER V

# STRUCTURAL DAMAGE FROM AIR BLAST

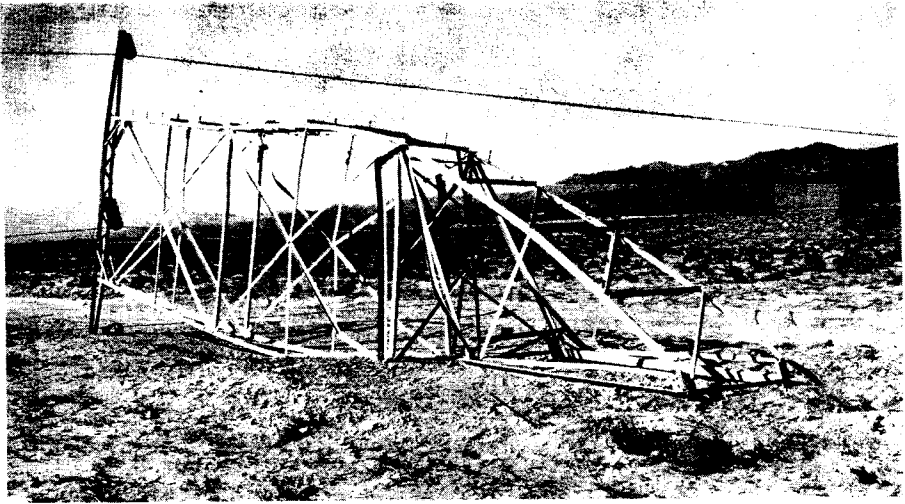
Figure 5.102a. Collapsed suspension tower (5 psi peak overpressure, 0.6 psi dynamic pressure from 30-kiloton explosion), Nevada Test Site.

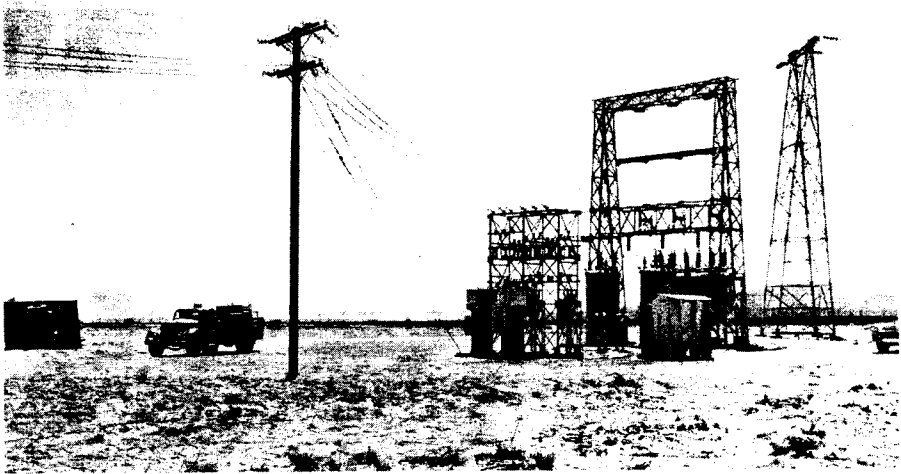
Figure 5.102b. Dead-end tower, suspension tower, and transformers (5 psi peak overpressure, 0.6 psi dynamic pressure from 30-kiloton explosion), Nevada Test Site. The trucks at the left of the photograph are those in Figure 5.89.

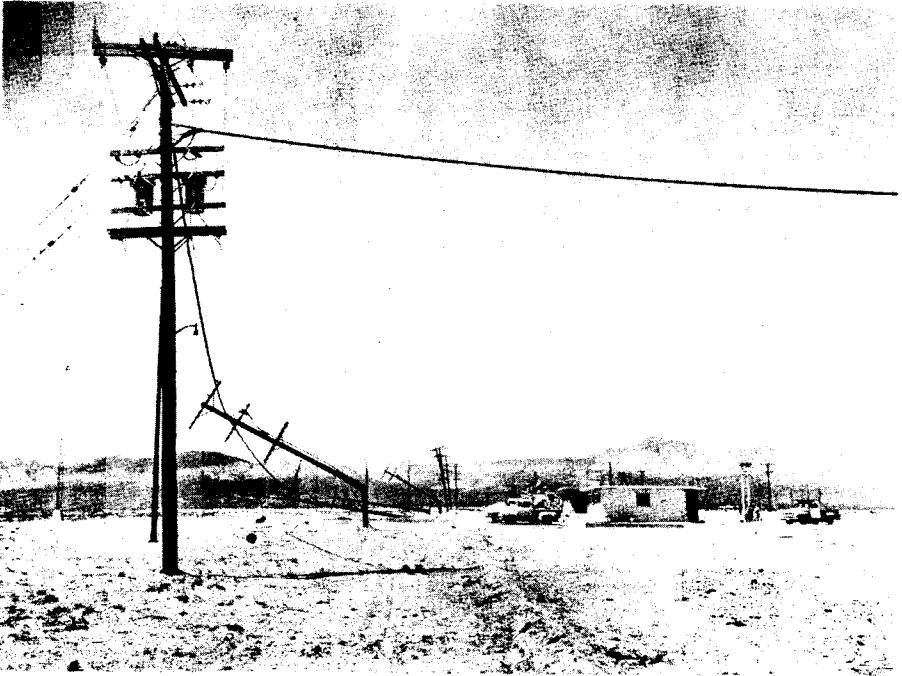
Figure 5.104. Collapse of utility poles on line (5 psi peak overpressure, 0.6 psi dynamic pressure from 30-kiloton explosion), Nevada Test Site.

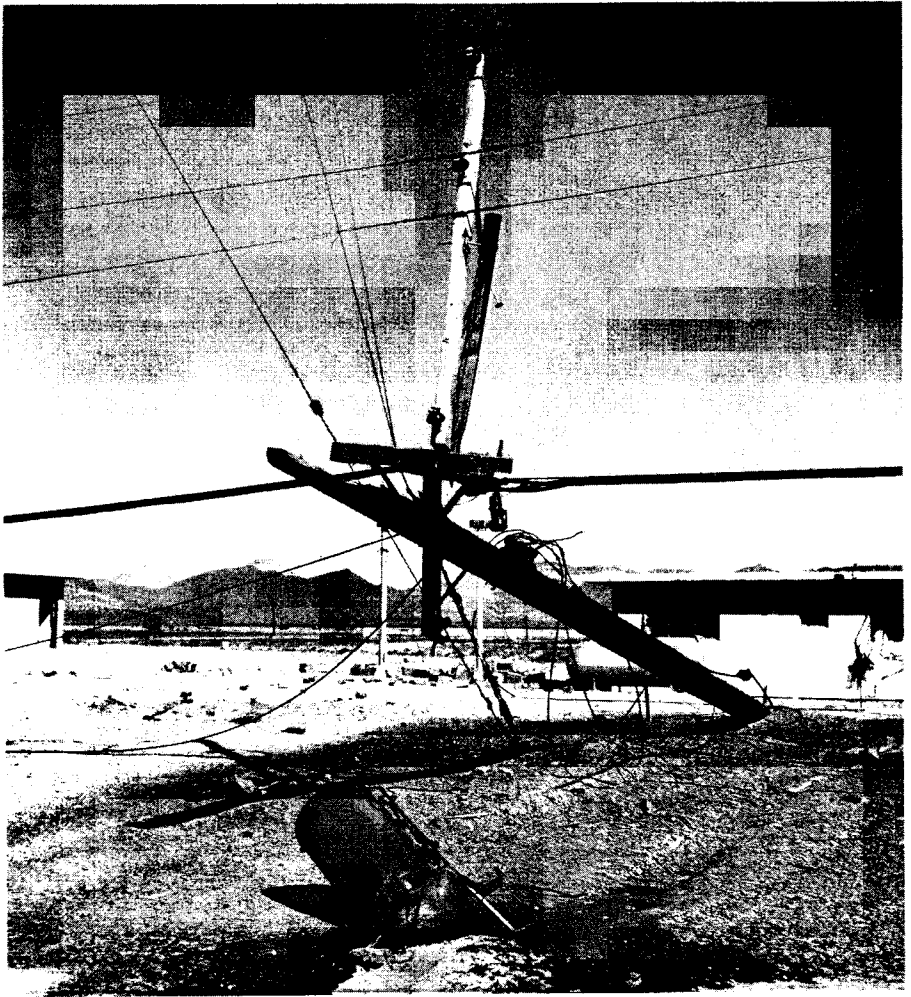
Figure 5.105. Transformer fallen from collapsed utility pole (5 psi peak overpressure), Nevada Test Site.

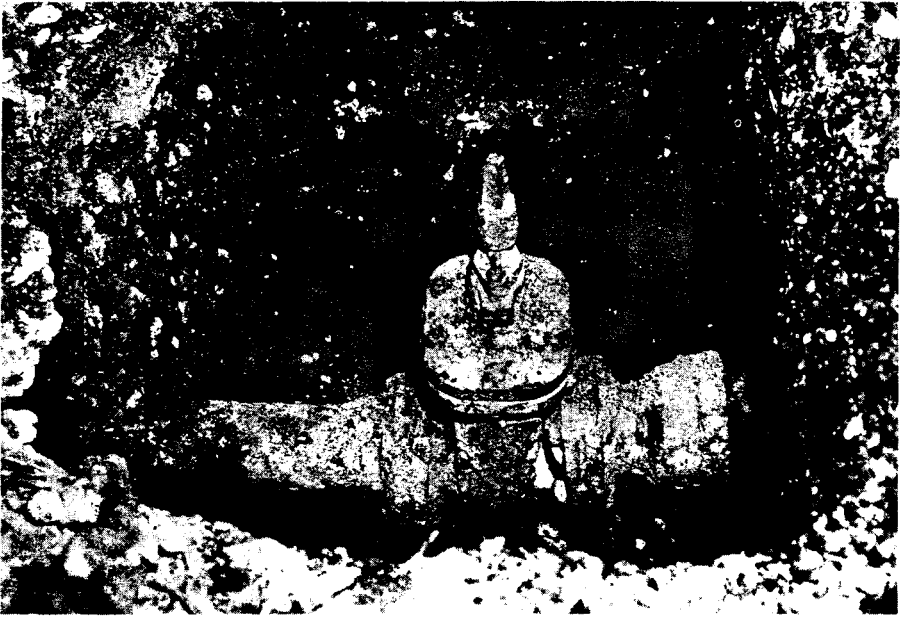
Figure 5.106a. Four-inch gate valve in water main broken by debris from brick wall (0.23 mile from ground zero at Hiroshima).

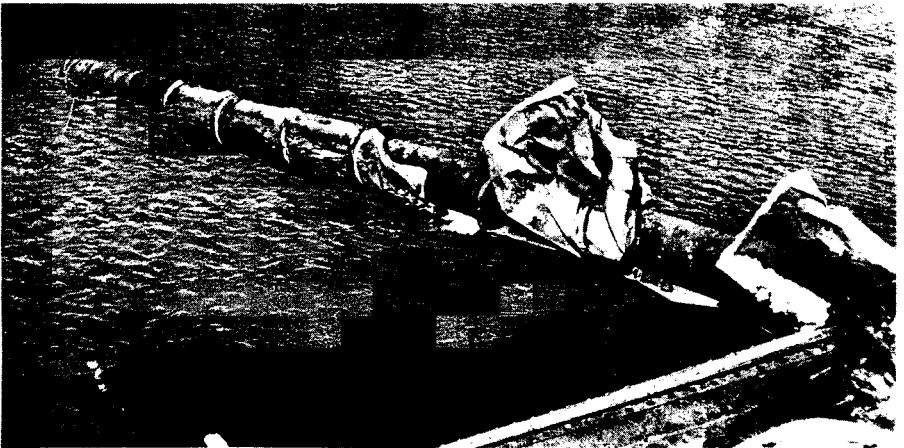
Figure 5.106b. Broken portion of 16-inch water main carried on bridge (0.23 mile from ground zero at Hiroshima).

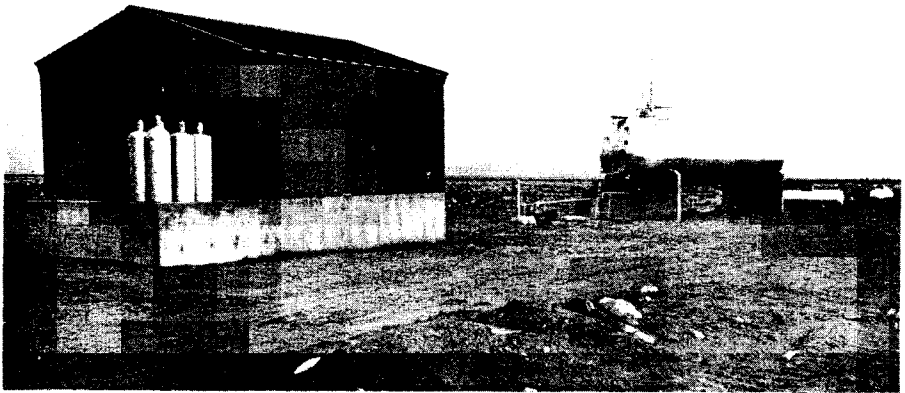
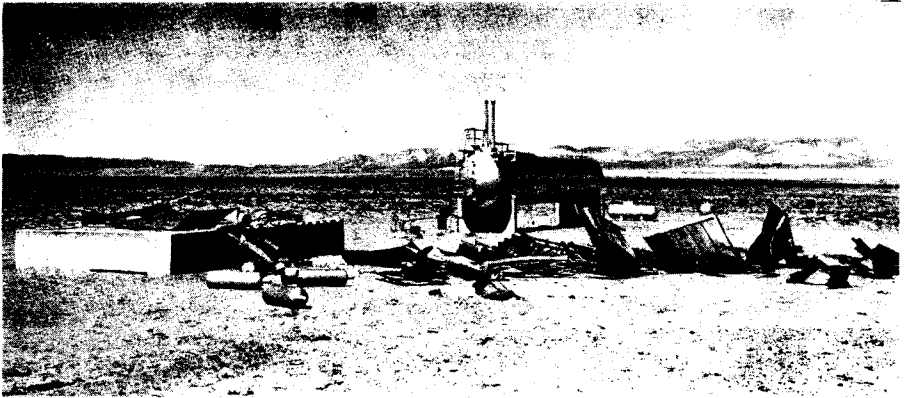
Figure 5.120. Upper photo: LP-gas bulk storage and filling plant before a nuclear explosion. Lower photo: The plant after the explosion (5 psi peak overpressure).

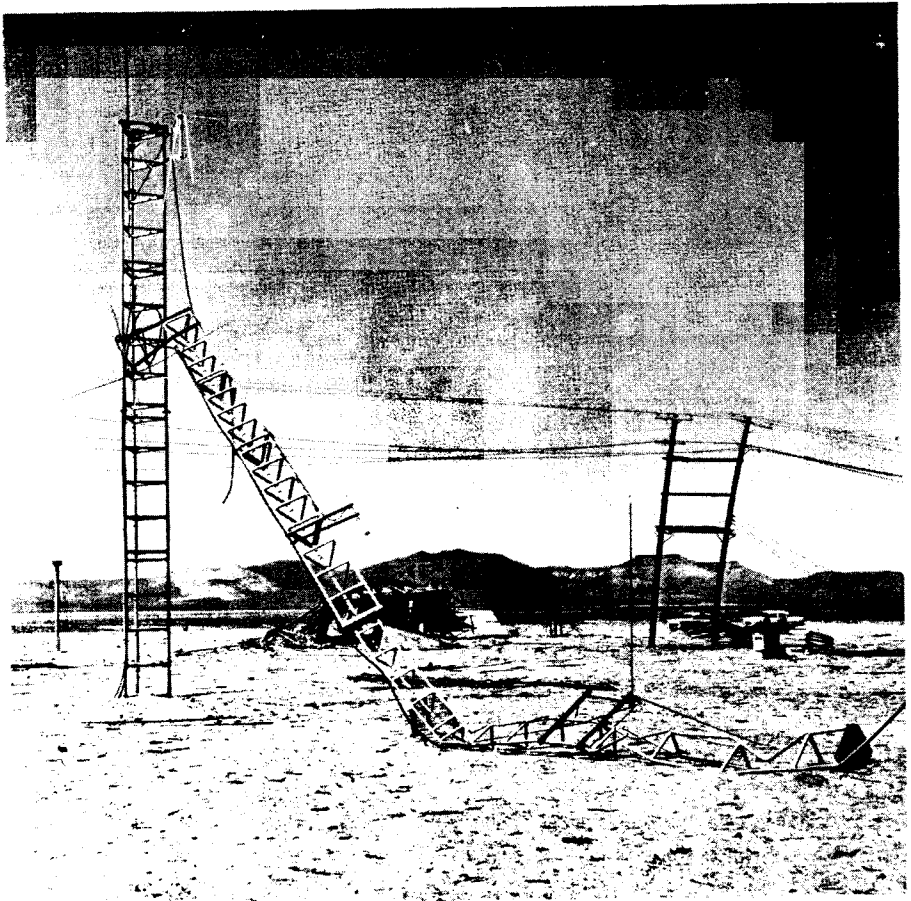
Figure 5.124. Unguyed lightweight 120-foot antenna tower (5 psi peak overpressure, 0.6 psi dynamic pressure from 30-kiloton explosion), Nevada Test Site.

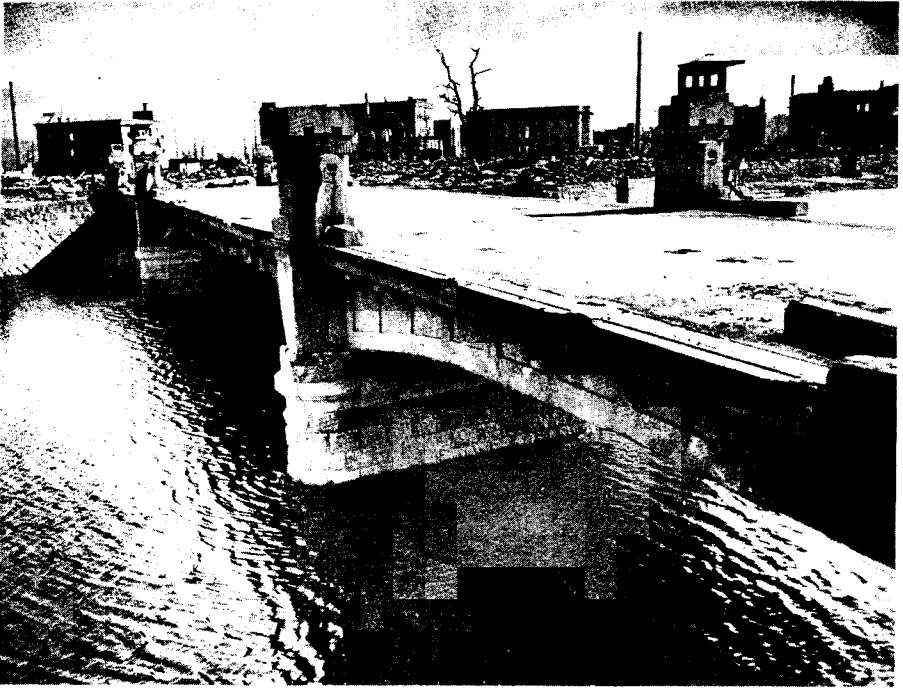
Figure 5.127a. Bridge with deck of reinforced concrete on steel-plate girders; outer girder had concrete facing (270 feet from ground zero at Hiroshima). The railing was blown down but the deck received little damage so that traffic continued.

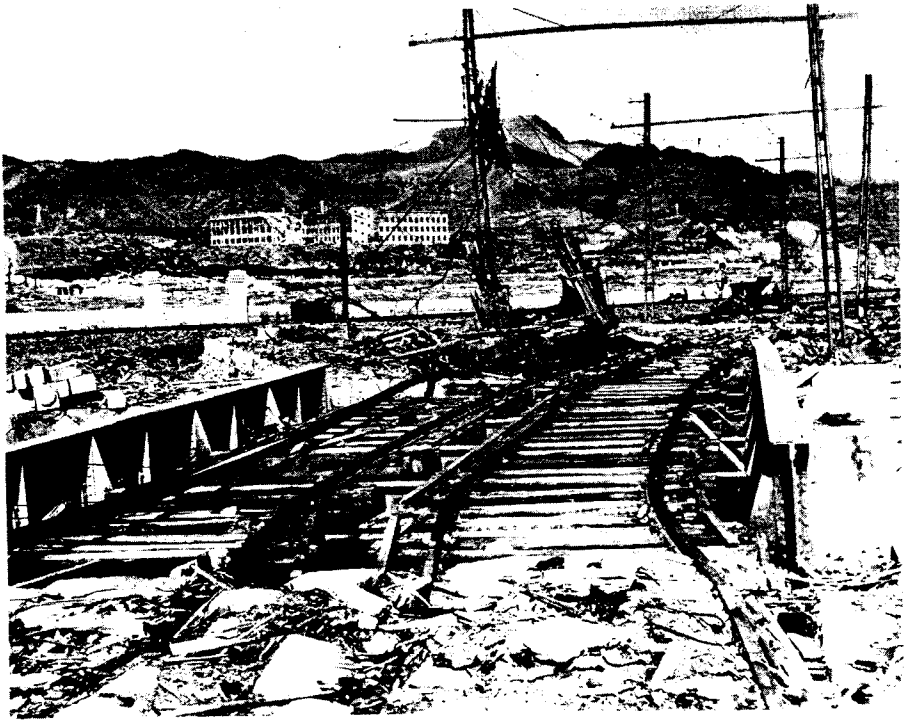
Figure 5.127b. A steel-plate girder, double-track railway bridge (0.16 mile from ground zero at Nagasaki). The plate girders were moved about 3 feet by the blast; the railroad track was bent out of shape and trolley cars were demolished, but the poles were left standing.

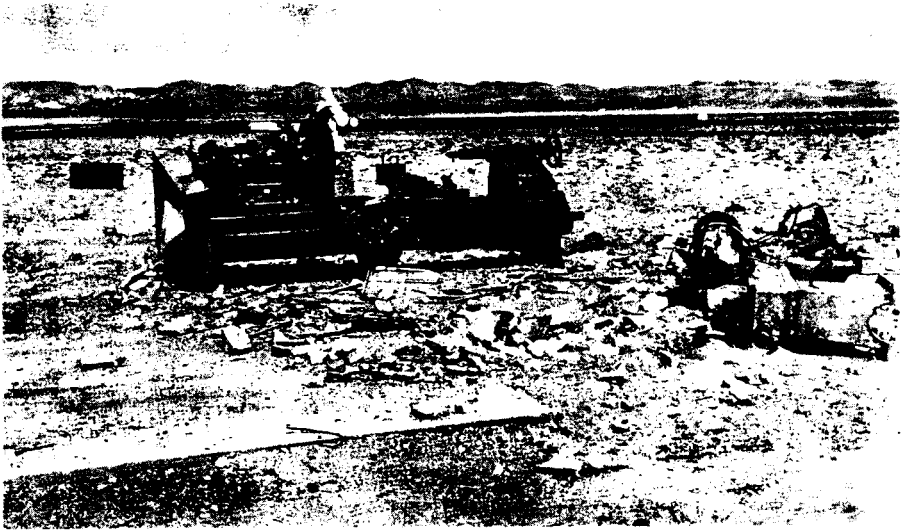
Figure 5.129a. Machine tools after a nuclear explosion (10 psi peak overpressure).

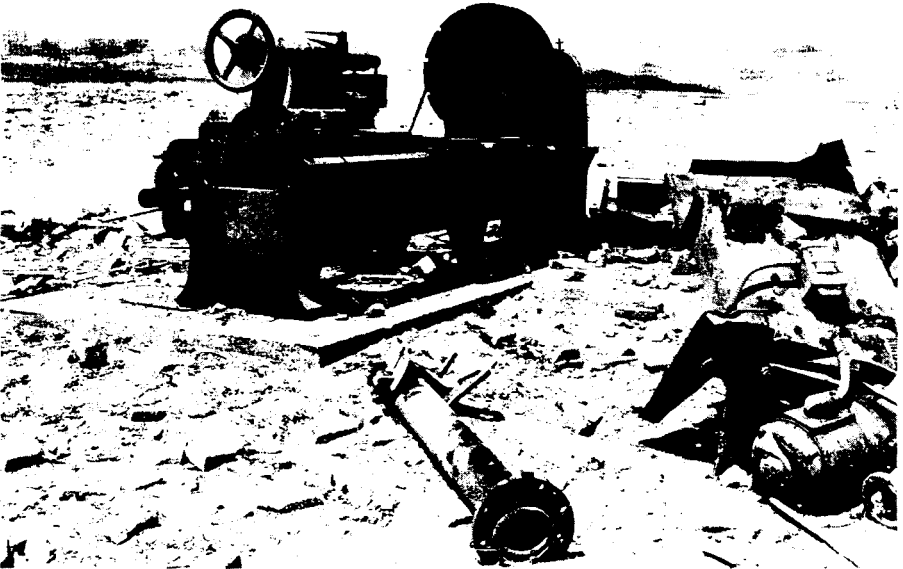
Figure 5.129b. Heavy-duty lathe after a nuclear explosion (10 psi peak overpressure).
