## CHAPTER V

# STRUCTURAL DAMAGE FROM AIR BLAST

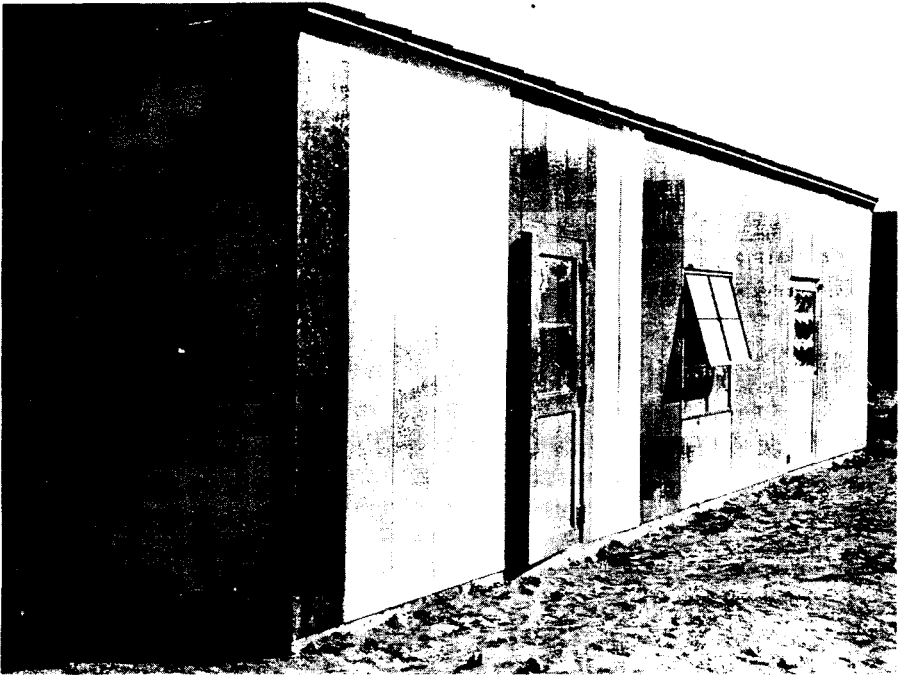
Figure 5.40a. Exterior of self-framing steel panel building before a nuclear explosion, Nevada Test Site.

**5.40** A frameless structure with self-supporting walls and roof of light, channel-shaped, interlocking, steel panels (16 inches wide) represented the second standard type of industrial building (Fig. 5.40a). The one subjected to 3.1 pounds per square inch peak overpressure (and a dynamic pressure of

0.2 pound per square inch) was completely demolished (Fig. 5.40b). One or two segments of wall were blown as far as 50 feet away, but, in general, the bent and twisted segments of the building remained approximately in their original locations. Most of the wall sections were still attached to their foundation bolts on the side and rear walls of the

5.42 It appears that the steel panel type of structure is repairable if exposed to overpressures of not more than about  $\frac{3}{4}$  to 1 pound per square inch. The buildings are simple to construct but they do not hold together well under

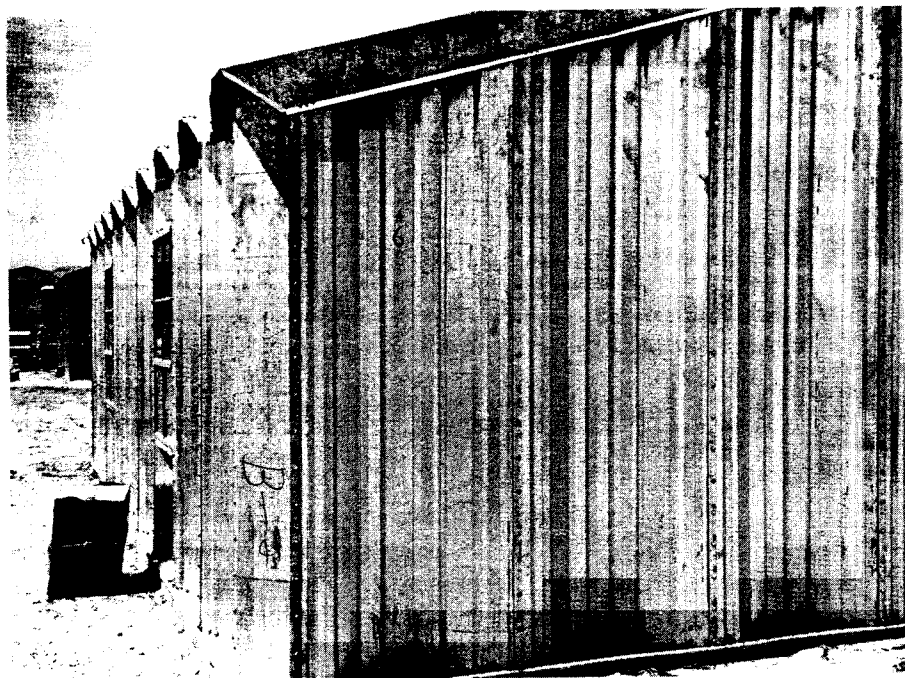
Figure 5.43. Self-framing corrugated steel panel building before a nuclear explosion, Nevada Test Site.

5.43 The third type of industrial building was a completely frameless structure made of strong, deeply-corrugated 43-inch wide panels of 16-gauge steel sheet. The panels were held together with large bolt fasteners at the sides and at the eaves and roof ridge. The wall panels were bolted to the concrete foundation. The entire structure was self-supporting, without frames, girts, or purlins (Fig. 5.43).

5.44 At a peak overpressure of 3.1 and a dynamic pressure of 0.2 pound per square inch a structure of this type was badly damaged, but all the pieces remained bolted together, so that the structure still provided good protection from the elements for its contents. The front slope of the roof was crushed downward, from 1 to 2 feet, at midsection, and the ridge line suffered moderate deflection. The rear slope of the roof appeared to be essentially undamaged (Fig. 5.44).

5.45 The front and side walls were buckled inward several inches, and the door in the front was broken off. All the windows were damaged to some extent, although a few panes in the rear remained in place.

5.47 The corrugated steel, frameless structure proved to be the most blast-resistant of those tested. It is believed that, provided the overpressure did not exceed about 3 pounds per square inch, relatively minor repairs would make possible continued use of the building. Improvement in the design of doors and windows, so as to reduce the missile hazard from broken glass, would be advantageous.

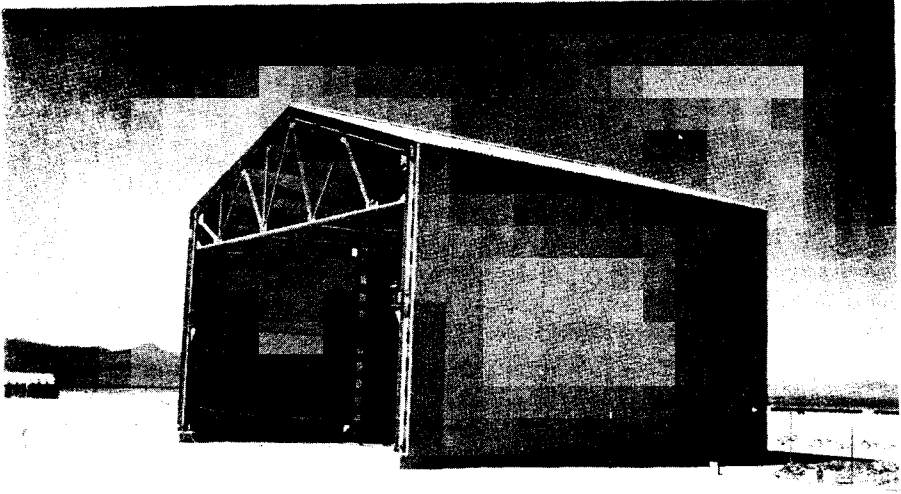
Figure 5.48a. Steel-frame building with siding and roof of frangible material.

tions in the kiloton and megaton ranges. Two representative types of small industrial buildings were chosen for these tests. One had a steel frame covered with siding and roofing of a frangible material and was considered to be a drag-type structure (Fig. 5.48a). The other had the same steel frame and roofing, but it had concrete siding with a window opening of about 30 percent of the wall area; this was regarded as a semidrag structure (Fig. 5.48b).

bolts failed, and yielding was found between the lower chord (horizontal member of the roof truss) and column connections. The girts on the windward side were severely damaged and all of the siding was completely blown off (Fig. 5.49).

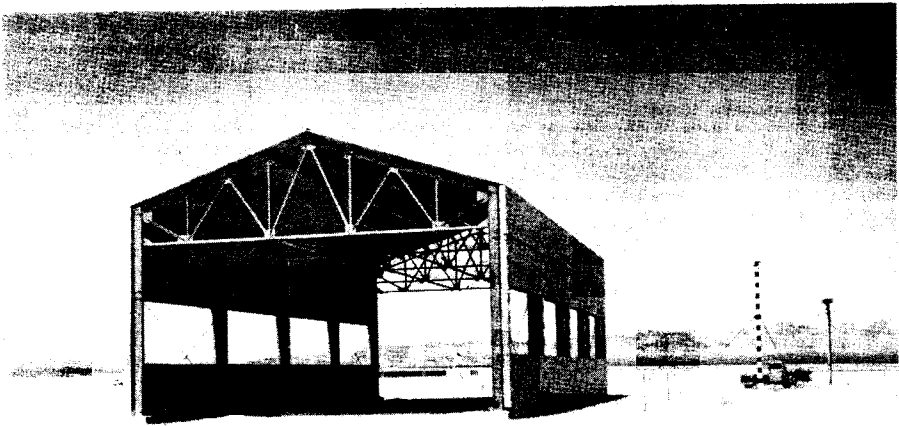
Figure 5.48b. Steel-frame building with concrete siding and window openings of 30 percent of the wall area.

**5.50** The second building, with the stronger siding, was exposed in Nevada to a peak overpressure loading of about 3.5 and a dynamic pressure of 0.3 pounds per square inch, with a positive phase duration of 1 second. Damage to this structure was small (Fig. 5.50). Although almost the whole of the frangible roof was blown off, the only other damage observed was a small yielding at some connections and column bases.

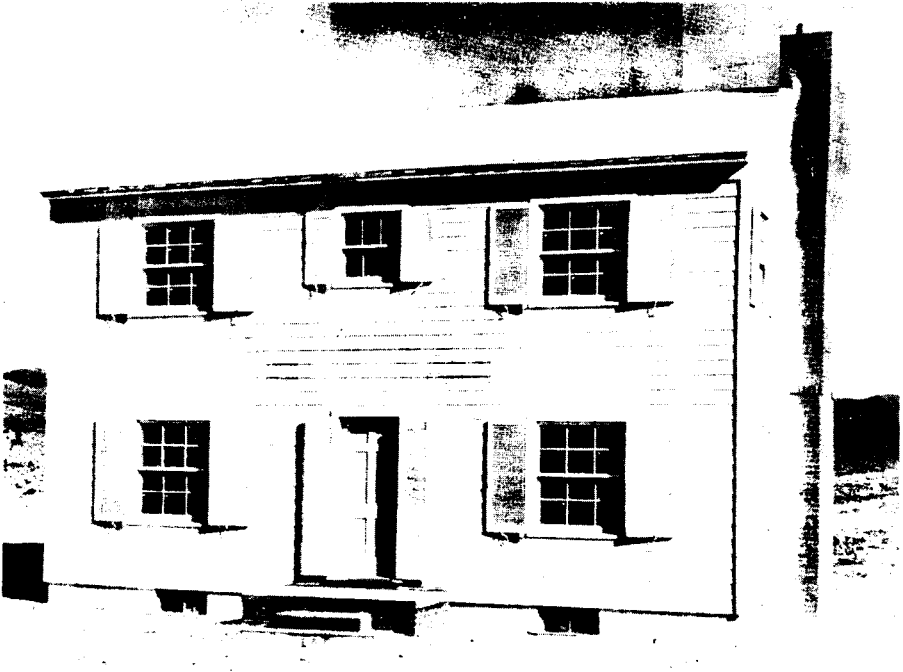
Figure 5.55. Wood-frame house before a nuclear explosion, Nevada Test Site.

different locations. They were of typical wood-frame construction, with two stories, basement, and brick chimney (Fig. 5.55). The interiors were plastered but not painted. Since the tests were intended for studying the effects of blast, precautions were taken to prevent the houses from burning. The exteriors were consequently painted white (except for the shutters), to reflect the thermal radiation. For the same purpose, the windows facing the explosion were equipped with metal venetian blinds having an aluminum finish. In addition, the houses were roofed with light-gray shingles; these were of asbestos cement for the house nearer to the explosion where the chances of fire were greater, whereas asphalt shingles were used for the other house. There were no utilities of any kind.

**5.56** One of the two houses was located in the region of Mach reflection where the peak incident overpressure was close to 5 pounds per square inch. It was expected, from the effects in Japan, that this house would be almost completely destroyed—as indeed it was—but the chief purpose was to see what protection might be obtained by persons in the basement.

**5.57** Some indication of the blast damage suffered by this dwelling can be obtained from Fig. 5.57. It is apparent that the house was ruined beyond repair. The first story was completely demolished and the second story, which was very badly damaged, dropped down on the first floor debris. The roof was blown off in several sections which landed at both front and back of the house. The gable end walls were blown apart and outward, and the brick chimney was broken into several pieces.

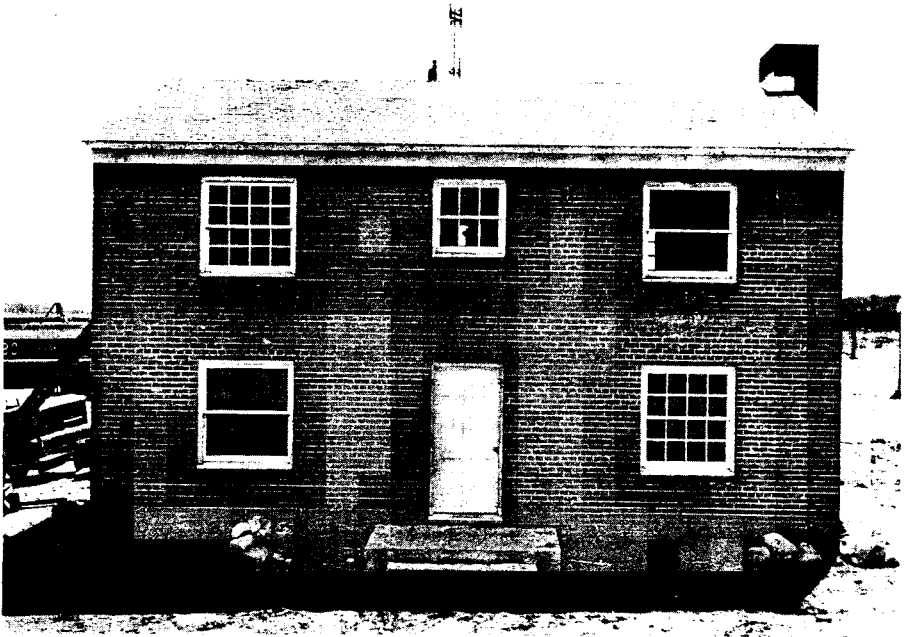
Figure 5.66. Unreinforced brick house before a nuclear explosion, Nevada Test Site.

**5.66** For comparison with the tests on the two-story, wood-frame structures made in Nevada in 1953, two brick-wall-bearing houses of conventional construction, similar in size and layout, were exposed to 5 and 1.7 pounds per square inch peak overpressure, respectively, in the 1955 tests (Fig. 5.66). The exterior walls were of brick veneer and cinder block and the foundation walls of cinder block; the floors, partitions, and roof were wood-framed.

**5.67** At an incident peak overpressure of 5 pounds per square inch, the brick-wall house was damaged beyond

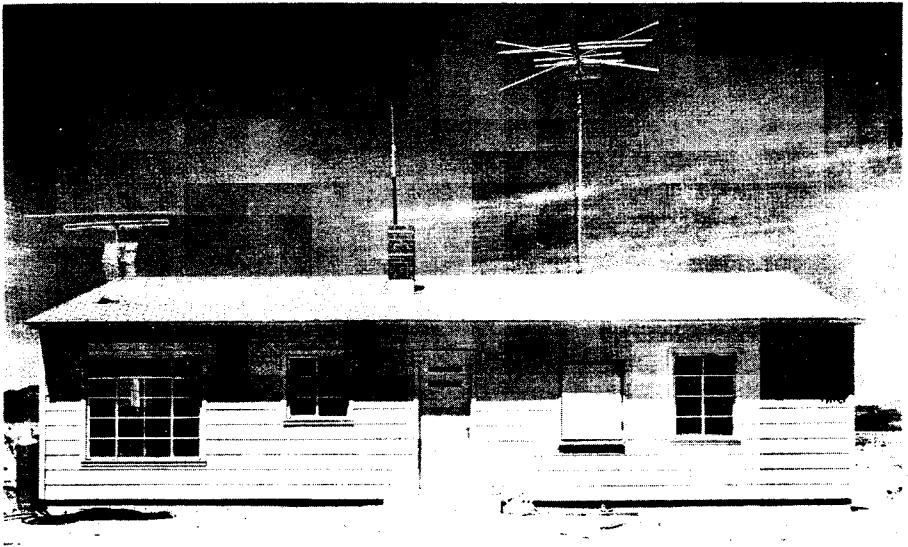
Figure 5.69. Rambler-type house before a nuclear explosion, Nevada Test Site. (Note blast door over bathroom window at right.)

5.69 A pair of the so-called "rambler" type, single-story, wood-frame houses were erected at the Nevada Test Site on concrete slabs poured in place at grade. They were of conventional design except that each contained a shelter, above ground, consisting of the bathroom walls, floor, and ceiling of reinforced concrete with blast door and shutter (Fig. 5.69).

5.70 When exposed to an incident peak overpressure of about 5 pounds per square inch, one of these houses was demolished beyond repair. However, the bathroom shelter was not damaged at all. Although the latch bolt on the blast shutter failed, leaving the shutter unfastened, the window was still intact. The roof was blown off and the rafters were split and broken. The side walls at gable ends were blown outward, and fell to the ground. A portion of the front wall remained standing, although it was leaning away from the direction of the explosion (Fig. 5.70).

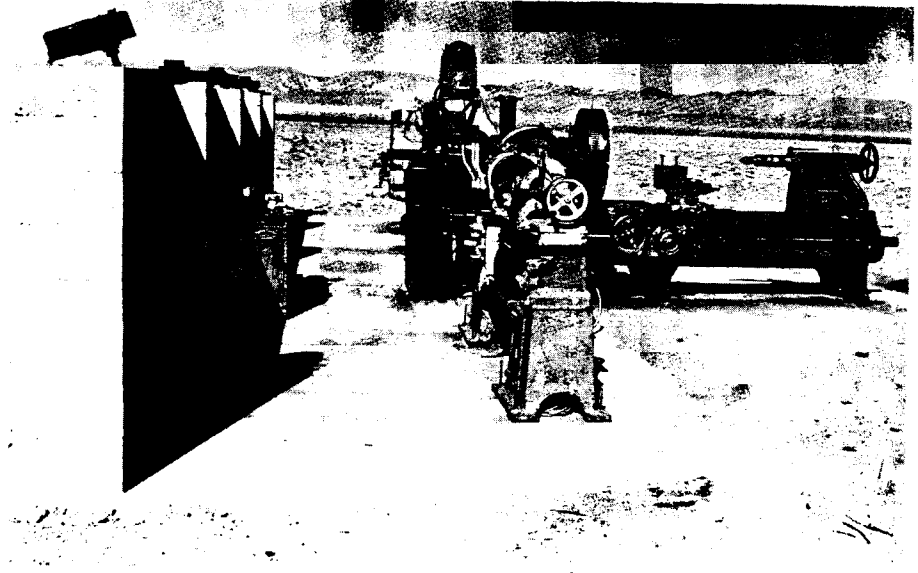
Figure 5.128. Machine tools behind masonry wall before a nuclear explosion, Nevada Test Site.

much of which resulted from the expected complete demolition of the concrete-block wall. Delicate mechanisms and appendages, which are usually on the exterior and unprotected, suffered especially severely. Gears and gear cases were damaged, hand valves and control levers were broken off, and drive belts were broken. It appears, however, that most of the missile damage could be easily repaired if replacement parts were available, since major dismantling would not be required.

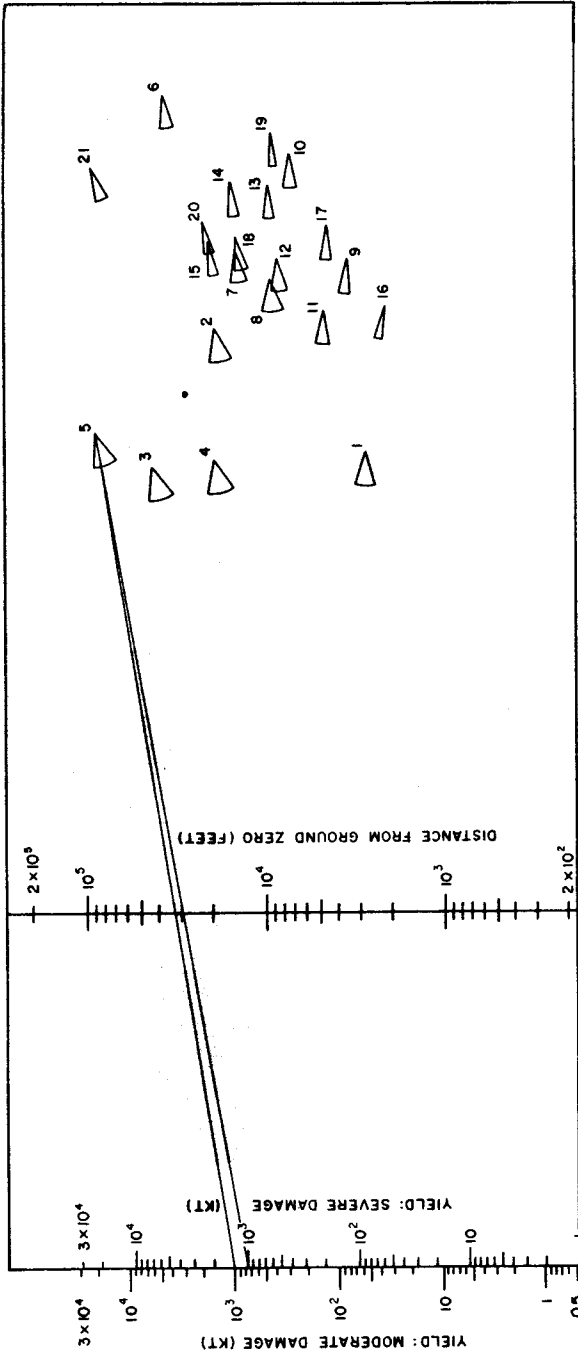
Figure 5.140. Damage-distance relationships for above ground structures.

**5.140** The ranges for severe and moderate damage to the structures in Tables 5.139a and b are presented in Fig. 5.140, based on actual observations and theoretical analysis. The numbers (1 to 21) in the figure identify the target types as given in the first column of the tables. The data refer to air bursts with the height of burst chosen so as to maximize the radius of damage for the particular target being considered and is not necessarily the same for different targets. For a surface burst, the respective ranges are to be multiplied by three-fourths. An example illustrating the use of the diagram is given.

The various above-ground structures in Fig. 5.140 are identified (Items 1 through 21) and the different types of damage are described in Tables 5.139a and b. The "fan" from each point indicates the range of yields for which the diagram may be used. For a surface burst multiply the damage distances obtained from the diagram by three-fourths. The results are estimated to be accurate within  $\pm 20$  percent for the average target conditions specified in § 5.141.

**5.141** The data in Fig. 5.140 are for certain average target conditions. These are that (1) the target is at sea level (no correction is necessary if the target altitude is less than 5,000 feet); (2) the terrain is fairly flat (rugged terrain would provide some local shielding and protection in certain areas and local enhancement of damage in others); and (3) the structures have average characteristics (that is, they are of average size and strength and that orientation of the target with respect to the burst is no problem, i.e., that the ratio of loading to resistance is relatively the same in all directions from the target).

**5.143** Figure 5.140 gives the distances from ground zero for severe and moderate damage. Light damage to all targets except blast-resistant structures and bridges can be expected at the range at which the overpressure is 1 pound per square inch. For the blast-resistant structure (Type 1) described in Table 5.139a, a peak overpressure of 10 pounds per square inch should be used to estimate the distance for light damage. Light damage to bridges can be expected at the range at which 0.6

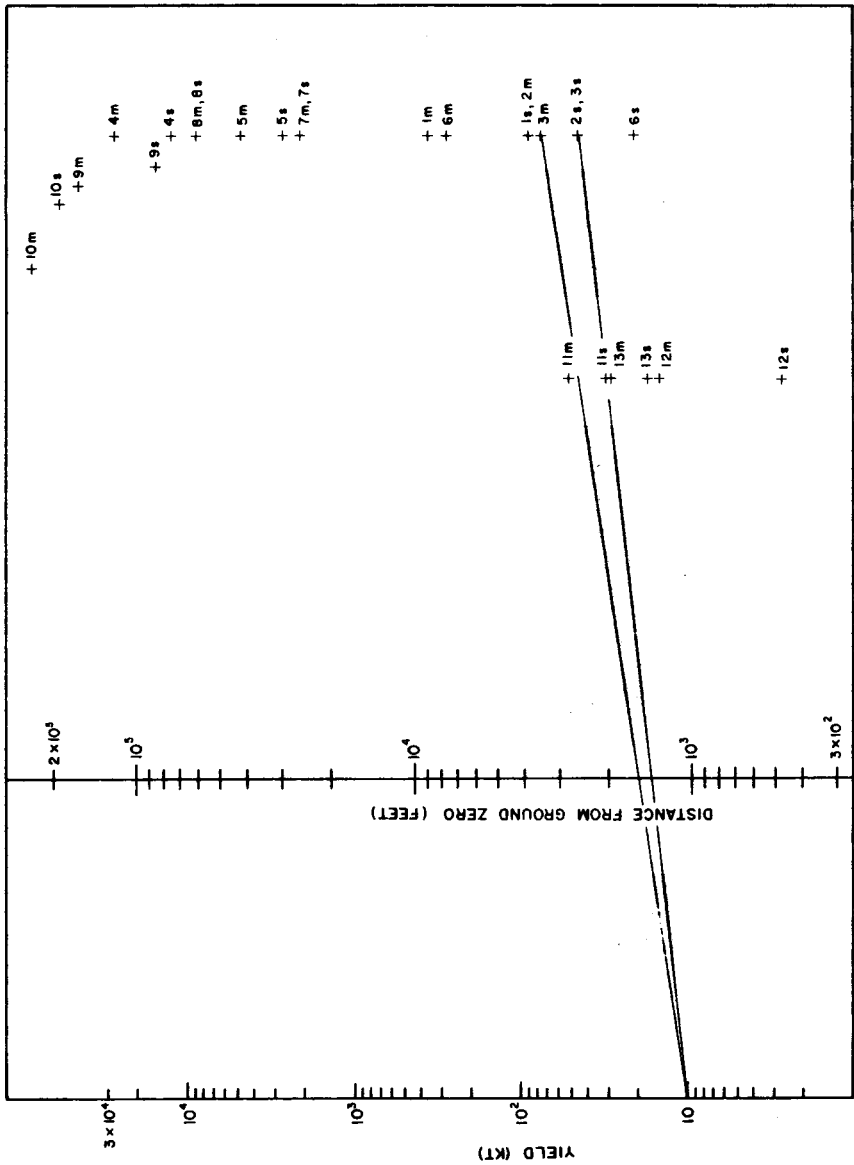
Figure 5.146. Damage-distance relationships for drag-sensitive targets.

**5.146** A diagram of damage-distance relationships for various targets which are largely affected by drag forces is given in Fig. 5.146. The conditions under which it is applicable and the

limits of accuracy are similar to those in § 5.141 and § 5.142, respectively; the possibility of fire mentioned in § 5.144 must also be kept in mind. The targets (Items 1 to 13) in the figure are enumerated on the page facing Fig. 5.146 and the different types of damage are described in the following paragraphs.
